## Observed behaviour of earthen structures during the Pisco earthquake (Peru)

M. Blondet<sup>1</sup>, J. Vargas<sup>2</sup> and N. Tarque<sup>3</sup>

### ABSTRACT :

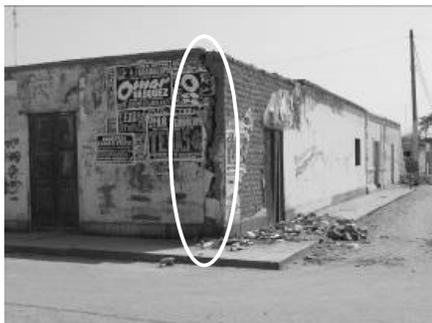
As observed in all the visited cities, the collapse in earthen constructions was triggered by the progressive formation of cracks in the walls. The most common types were vertical cracks at the wall's corners and the x-shaped cracks in the façade walls. The cracking of the walls triggered the collapse of the structure and the partial or complete overturning of the walls caused the roof's collapse. The effect that the earthquake had on adobe constructions was catastrophic. In the Pisco area, for example, nearly 80% of the adobe buildings were completely damaged and destroyed by the earthquake. The high collapse percentage on the adobe buildings can be attributed mainly to the lack of seismic reinforcement on the dwellings. The reinforcement would have contributed to the displacement control between the walls, avoiding their collapse and allowing them to withstand further seismic movements. Other factors that influenced the buildings' collapse and that were responsible for much of the structural damage were the soft soils, the low quality of the building materials and the labour, the thinness of the walls, the inadequate configuration and location of openings (doors and windows), and the weak bond in the intersection between the walls and the roof.

Figure 4 Vertical cracks in the wall's corner.

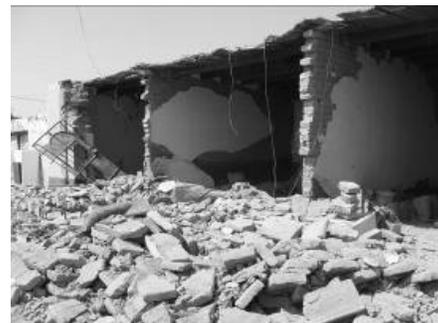
The most common failure observed in earthen buildings, especially in those with thin walls, was the overturning of the façade walls and their collapse onto the street. This was caused because the wall strength in the intersection between the façade wall and the other house walls was too low to withstand the earthquake's movement. The walls usually collapsed as follows: first vertical cracks appeared on the wall's corners causing the adobe blocks in that area start to break and fall (Figure 4). This triggered the walls to disconnect until finally the façade wall turned over (Figure 5). The situation was worsened by the fact that separation joints between the buildings seems to be an uncommon practice in the area. Consequently, the direct contact between the walls during seismic activity leads to their collapse.

The observations made after the earthquake have shown that the magnitude of the damage that the buildings suffered when their walls collapsed, was directly related to whether the roof's wooden joists were supported on the façade wall or not. If they were supported by the façade, the wall's collapse caused them come off balance, causing the roof to collapse as well. If, on the other hand, the joists were supported by the walls that were perpendicular to the façade wall, the roof didn't fall apart (Figure 5).

Figure 5 Collapse of the façade walls in adobe buildings.

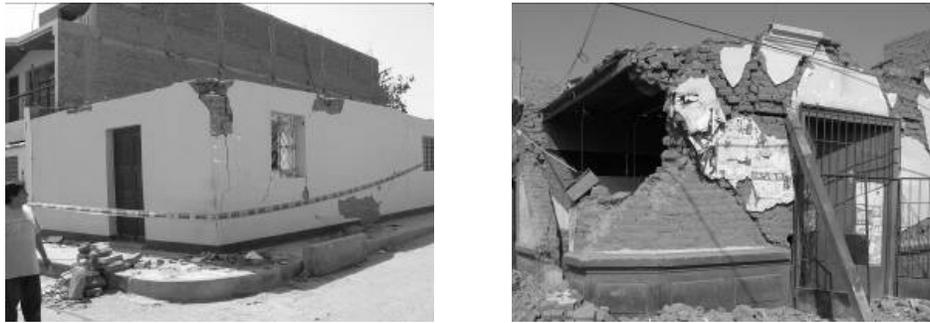
Many adobe buildings located on street corners suffered from heavy structural damage due to the collapse of their two façade walls and roof. The cracks produced on the corner between these two walls are both vertical and diagonal. The diagonal cracks extend from the highest part of each wall's corner down to the house base, forming a 'v' like crack pattern (Figure 6).

Figure 6 Diagonal and vertical cracks shown on corner buildings.

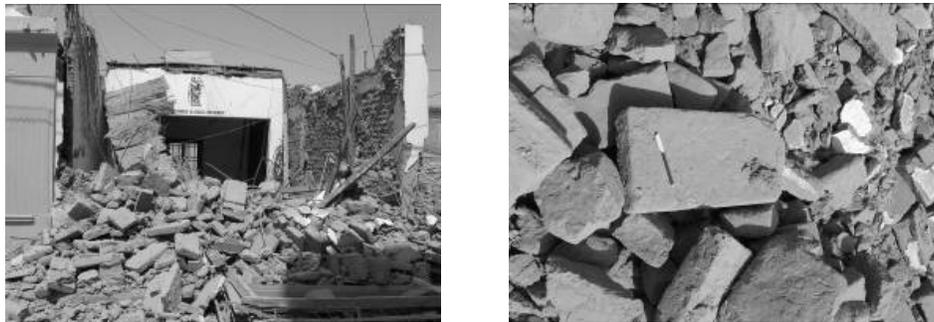
The adhesion between the adobes and mortar in most collapsed or heavily damaged walls (especially in the ones belonging to the more recent buildings in Pisco) is quite poor and weak. When the adobe walls collapsed, most of the adobe blocks that were used for these constructions didn't hold together with the mortar and crumbled (Figure 7). It is presumed that, as it is obtained from a coastal area, the soil used for the making of the bricks and mortar contains too much sand and too little clay, producing as a result a weak bond between the mortar and the adobe blocks. Unfortunately clay is the only soil component that, as a reaction to water contact, causes the soil particles to chemically bond. In some of the houses in the area, it was observed that the adobe used for the constructions would easily crumble when scratched with the nail.

Figure 7 These images show the weak bond between the mortar and the adobe blocks.

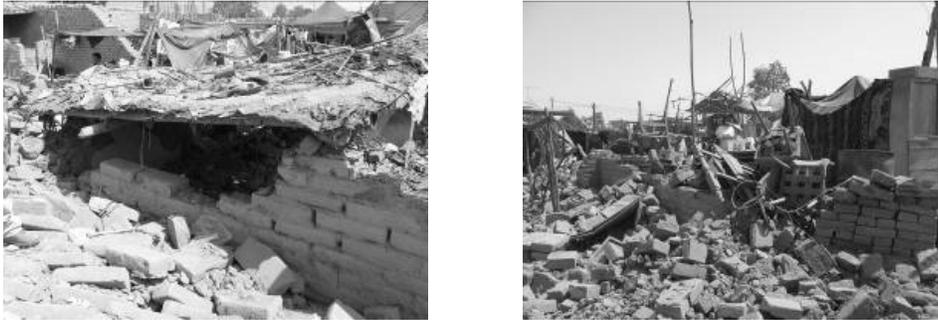
Some of the more recent buildings located on the developing areas around Guadalupe and Ica have been constructed without taking seismic security guidelines into consideration and are, therefore, more susceptible to suffer damage due to seismic activity than the older constructions in the area. The walls on the modern buildings are more susceptible to collapse due to out of plane loads as they are narrower (with a 0,25 m thickness) and more slender than the older walls. Many of the houses in the area only have 1 or 2 enclosed rooms, and many of them have enclosure walls constructed using adobe. The roofs were built using wood that was covered with crushed cane, straw mats, cardboards or sandbags, used as insulation to keep the house inhabitants warm. The floor of the houses is usually moistened soil that has been compacted. Most of the dwellings constructed following this model collapsed during the earthquake (Figure 8).

Figure 8 Collapse of buildings located on developing urban areas.

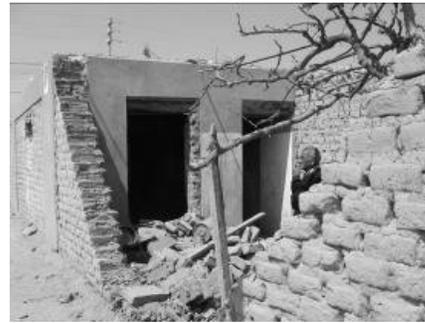
Between September 1998 and January 1999, a pilot plan was introduced by the CERESIS (South American Regional Center for Seismology) - GTZ (German Cooperation Agency) - PUCP project to reinforce adobe dwellings (San Bartolomé et al. 1999). 19 adobe constructions located in different areas all throughout Peru were reinforced to withstand seismic activity. The reinforcement system consisted on electro-welded steel mesh strips nailed to the walls and covered with cement and sand mortar. Vertical reinforcing strips were added to the walls' intersections and horizontal strips placed on the highest part of the walls. Two of these reinforced houses are located in the villages of Pachacutec and Guadalupe in Ica. None of these buildings suffered from any damage related to the earthquake. The reinforcement applied to these dwellings prevented the formation of vertical cracks. After the reinforcement was applied to the house in Guadalupe (Figure 9a), an enclosure wall was built by its owner without taking any seismic reinforcement considerations into account. This wall collapsed as observed in Figure 9b.

b) Collapsed enclosure wall

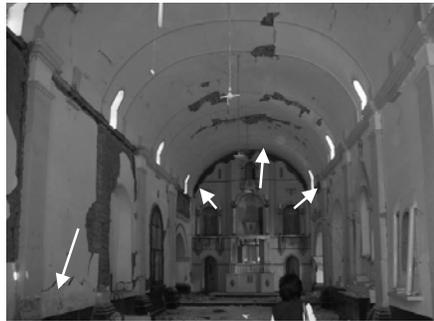
- Horizontal cracks on the lateral walls at about 1/3 of their total height (Figure 11a). These cracks can even break through the earthen pilasters (Figure 11b), causing the walls to collapse.
- Diagonal cracks on some of the lateral walls.
- Detachment of the choir (Figure 11c) and the altar's wall (parallel to the façade) from the church's lateral

walls and cylindrical vault ceiling (Figure 11a).

a) Detachment of the main

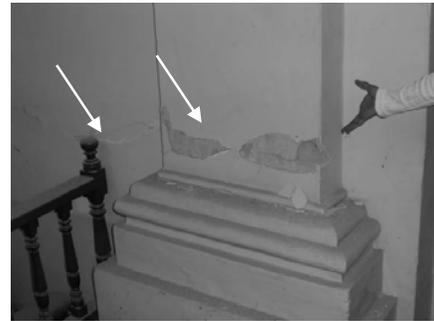
b) Horizontal crack in plaster

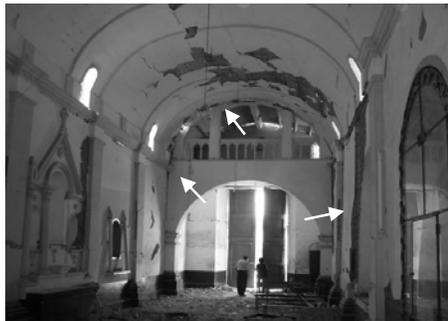
c) Detachment of the choir from the vault

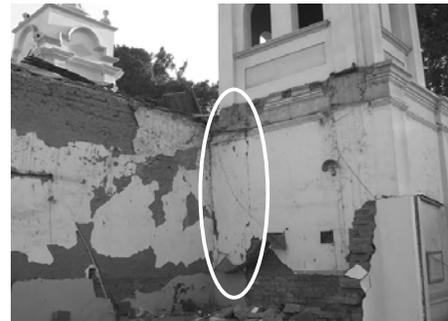
- Detachment of the towers from the rest of the church (Figure 11d).
- Appearance of vertical cracks and fissures on the church towers (11d).
- Humidity related damage.

d) Vertical cracks on the intersection between the tower and walls

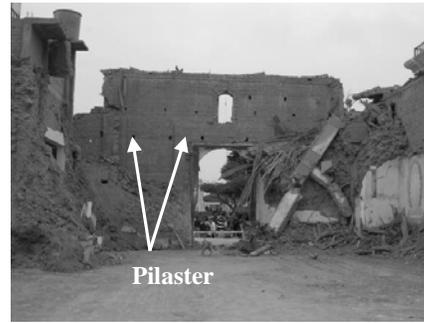
This church dates back to the XVIII century. Its façade was constructed using fired clay bricks masonry (Figure 12a) and its most outstanding feature were the two 4-storey high towers and 4 pilasters (that simulated columns) located equidistantly from the main entrance to the church (Figure 12b). The church’s lateral walls were built using adobe. The church had a cylindrical vaulted ceiling that was constructed using wooden arches and crushed cane covered by a mud and gypsum stucco. The roof rested on the lateral walls and the main altar’s wall had been reinforced using concrete frames. This reinforcement was probably a latter addition to the structure, most likely done during a more recent restoration of the church. There were 300 people attending a mass when the earthquake happened. About half of them died when the roof and walls collapsed. It is possible that the church’s collapse initiated with the cracking and overturning of the lateral walls, to which the roof followed.

b) Façade wall viewed from the inside of the church

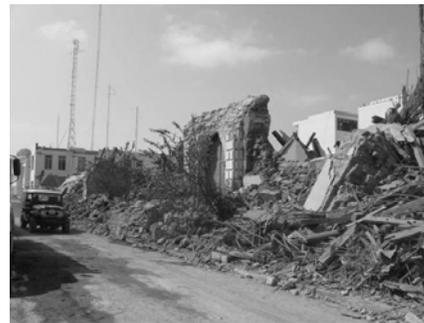
This church built in Baroque style in the XVII century (Figure 13a) had brick and adobe walls and, like previous churches, had a cylindrical vaulted ceiling. This church, however, presented opening in the intersections between the walls and the inner arches. As shown in Figure 13b, the church suffered from a complete collapse during the earthquake.

b) Lateral view of the church
