# BEHAVIOUR OF EARTHEN STRUCTURES DURING THE PISCO EARTHQUAKE (PERU)

Marcial Blondet<sup>1</sup>, Julio Vargas<sup>2</sup> and Nicola Tarque<sup>3</sup>

## ABSTRACT

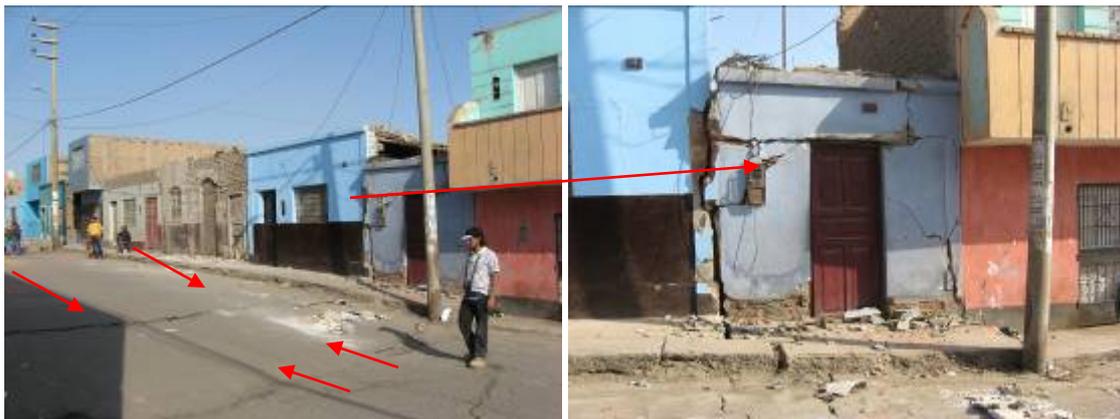
Due to the fact that Pisco's soil is composed of saturated sand layers, it is prone to suffer soil settlement or even to be affected by soil liquefaction, especially in the areas closer to the coast. Figure 7a shows the sedimentation that's taken place in one of Pisco's central areas (shown in the cracks on the sidewalk), and the damage this process has caused on one of the local buildings (Figure 7b.). In some coastal areas, like those near Pisco's waterfront, the soil has suffered from soil saturation due to the effect of the ocean and from dynamic compaction during the earthquake.

**a) Cracks on the pavement      b) Building that has suffered sedimentation problems**

**Figure 7.- Soil sedimentation**

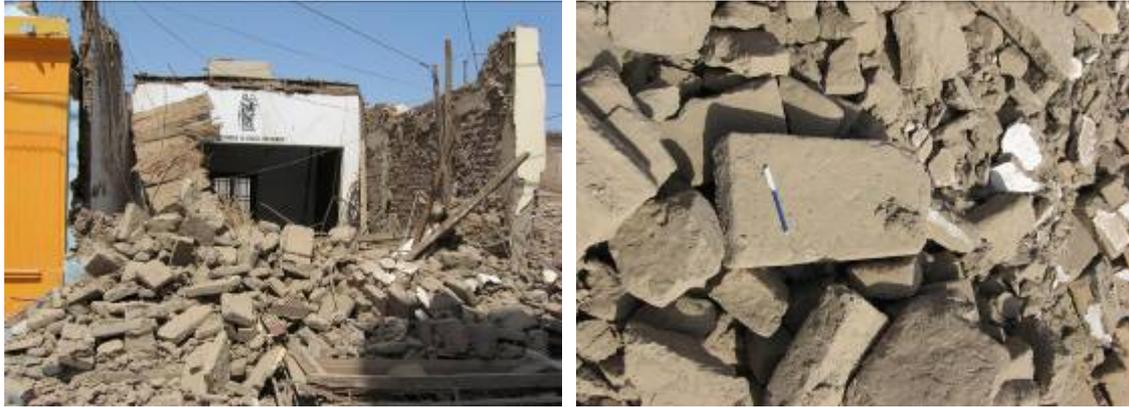
The adhesion between the adobes and mortar in most collapsed or heavily damaged walls (especially in the ones belonging to the more recent buildings in Pisco) is quite poor and weak. When the adobe walls collapsed, most of the adobe blocks that were used for these constructions didn't hold together with the mortar and crumbled (Figure 8).

It is presumed that, as it is obtained from a coastal area, the soil used for the making of the bricks and mortar contains too much sand and too little clay, producing as a result a weak bond between the mortar and the adobe blocks. Unfortunately clay is the only soil component that, as a reaction to water contact, causes the soil particles to chemically bond. In some of the houses in the area, it was observed that the adobe used for the constructions would easily crumble when scratched with the nail.

**Figure 8.-** These images show the weak bond between the mortar and the adobe blocks

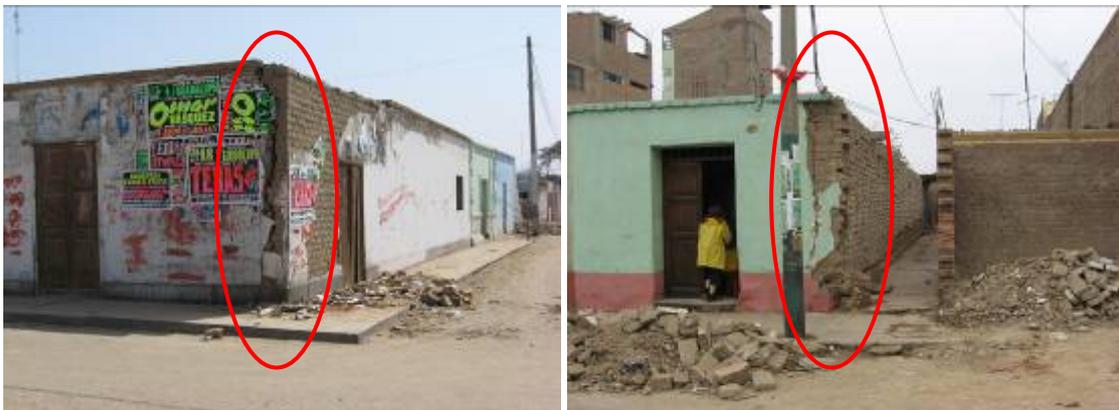
The most common failures observed in earthen buildings, especially in those with thin walls, were the overturning of the façade walls and their collapse onto the street. This was caused because the wall strength in the intersection between the façade wall and the other house walls was too low to withstand the earthquake's movement. The walls usually collapsed as follows: first vertical cracks appeared on the wall's corners causing the adobe blocks in that area start to break and fall (Figure 9). This triggered the walls to disconnect until finally the façade wall turned over (Figure 10). The situation was worsened by the fact that separation joints between the buildings seems to be an uncommon practice in the area. Consequently, the direct contact between the walls during seismic activity leads to their collapse.

**Figure 9. Vertical cracks in the wall's corners**

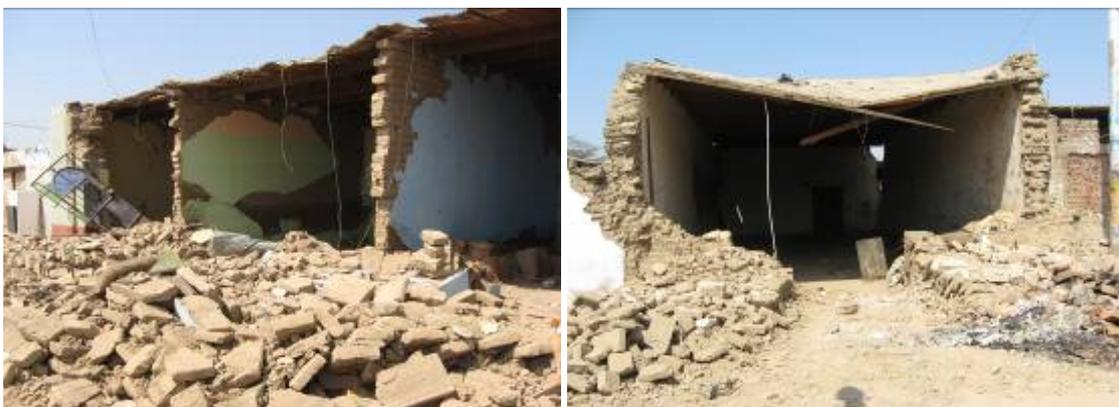
**Figure 10. Collapse of the façade walls in adobe buildings**

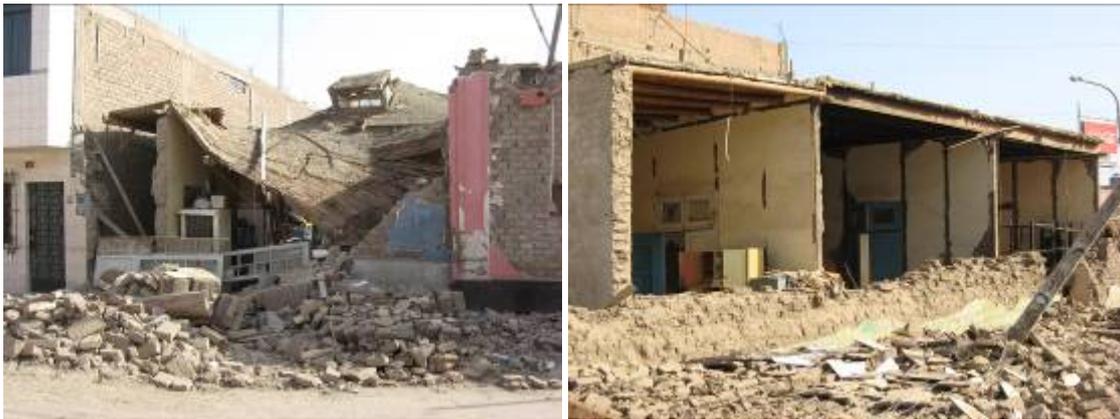
Figure 11. Roofs in adobe dwellings

The observations made after the earthquake have shown that the magnitude of the damage that the buildings suffered when their walls collapsed, was directly related to whether the roof's wooden joists were supported on the façade wall or not. If they were supported by the façade, the wall's collapse caused them come off balance, causing the roof to collapse as well (Figure 11a). If, on the other hand, the joists were supported by the walls that were perpendicular to the façade wall, the roof didn't fall apart (Figure 11b). In some cases; however, roofs that weren't supported by the façade wall collapsed as well because the lateral walls collapsed.

a) Roof supported by the façade wall

b) Roof that wasn't supported by the façade

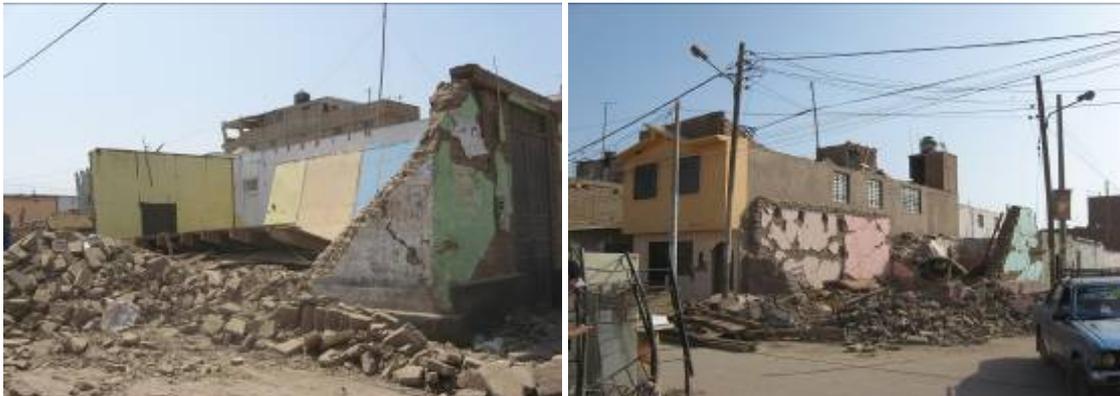
Many adobe buildings located on street corners suffered from heavy structural damage due to the collapse of their two façade walls and roof (Figure 12). The cracks produced on the corner between these two walls are both vertical and diagonal. The diagonal cracks extend from the highest part of each wall's corner down to the house base, forming a 'v' like crack pattern (Figure 13).

Figure 12. Collapsed dwellings located on street corners

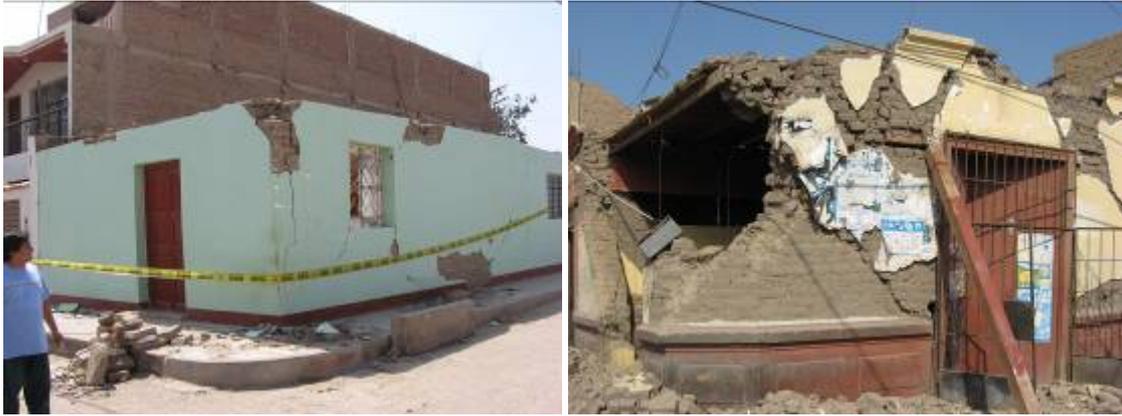
**Figure 13. Diagonal and vertical cracks shown on corner buildings**

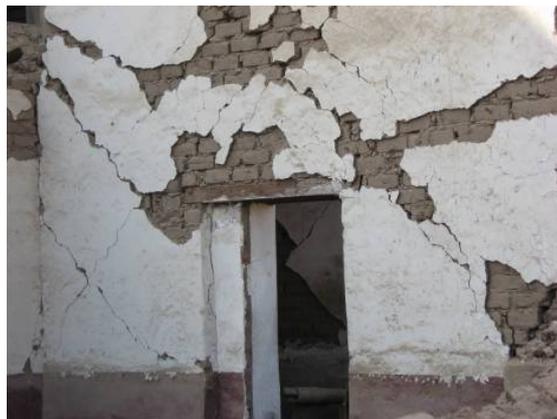
The walls that didn't overturn were able to withstand the earthquake's in plane actions. In some of these cases, however, the appearance of diagonal cracks was observed (Figure 15).

**Figure 15.- Flaw due to x-shaped cut on the wall.**

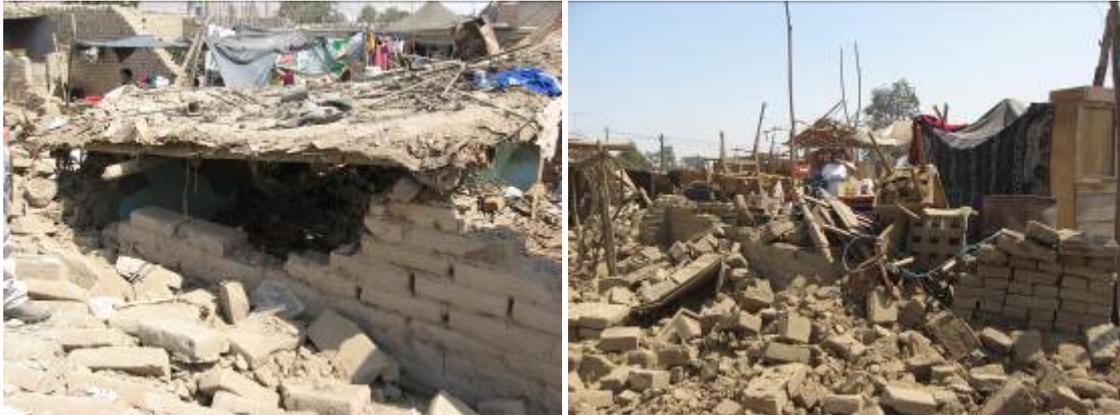
slender than the older walls. Many of the houses in the area only have 1 or 2 enclosed rooms, and many of them have enclosure walls constructed using adobe. The roofs were built using wood that was covered with crushed cane, straw mats, cardboards or sandbags, used as insulation to keep the house inhabitants warm. The floor of the houses is usually moistened soil that has been compacted. Because this method causes humidity to affect the walls by capillary action, the construction loses strength and stability. Most of the dwellings constructed following this model collapsed during the earthquake (Figure 16).

**Figure 16. Collapse of buildings located on developing urban areas**

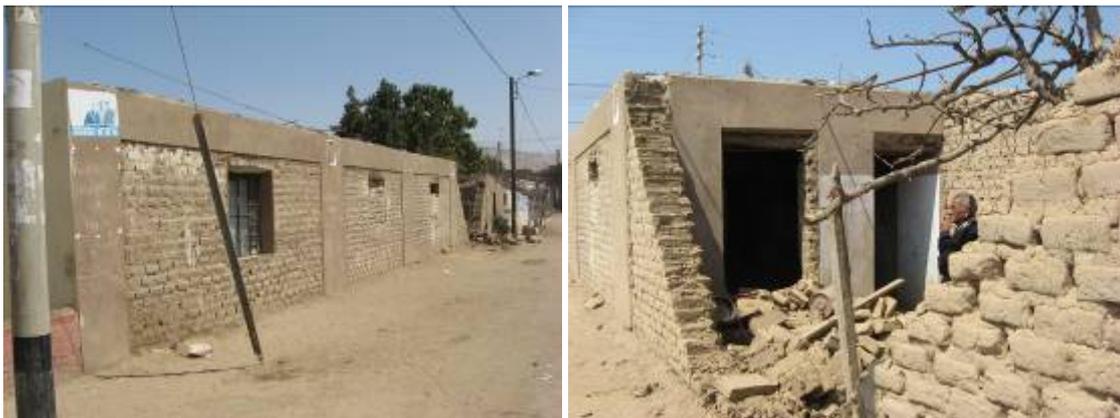
**Figure 18. Adobe construction in Guadalupe, Ica**

Two of these reinforced houses are located in the villages of Pachacútec and Guadalupe in Ica. None of these buildings suffered from any damage related to the earthquake. The reinforcement applied to these dwellings prevented the formation of vertical cracks. After the reinforcement was applied to the house in Guadalupe, an enclosure wall was built by its owner without taking any seismic reinforcement considerations into account (Figure 18a). This wall collapsed as observed in Figure 18b.

**a) Reinforced building**

**b) Collapsed enclosure wall**

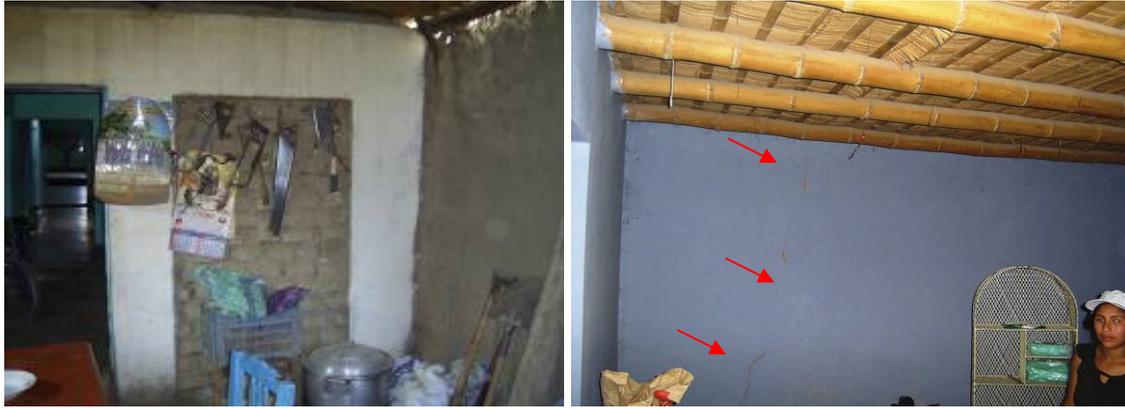
Figure 19a shows the house in Pachacútec that was reinforced as part of the pilot plan. The neighbouring building is a non-reinforced adobe house on which the earthquake caused little damage (Figure 19b). The reinforced construction apparently acted as a support for the non-reinforced dwelling, preventing its walls from collapsing. Figure 20 shows the after-shake state of a third building located at approximately 10 m from the pilot construction that has visibly suffered stronger damage.

a) Reinforced dwelling                      b) Unreinforced dwelling  
**Figure 19. Dwellings located in Pachacútec, Ica**

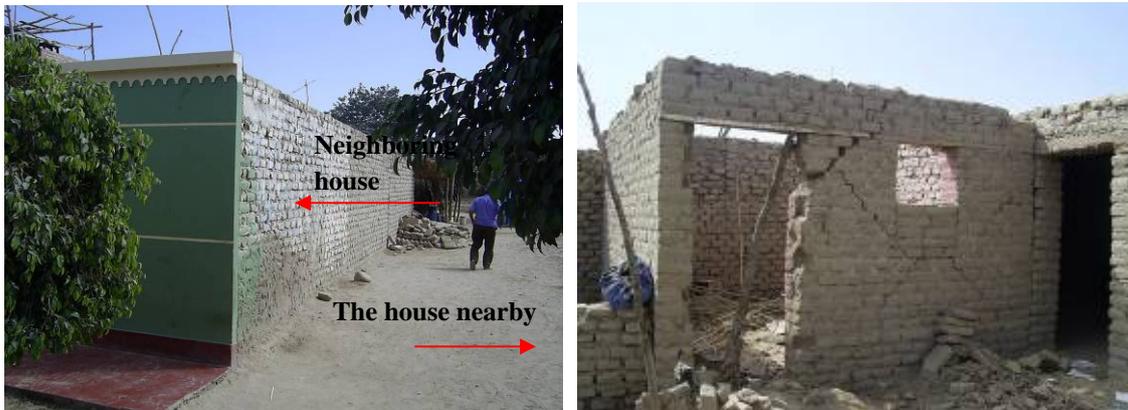
a) Neighboring house                      b) Nearby collapsed house  
**Figure 20b. Adobe dwellings near the reinforced house**

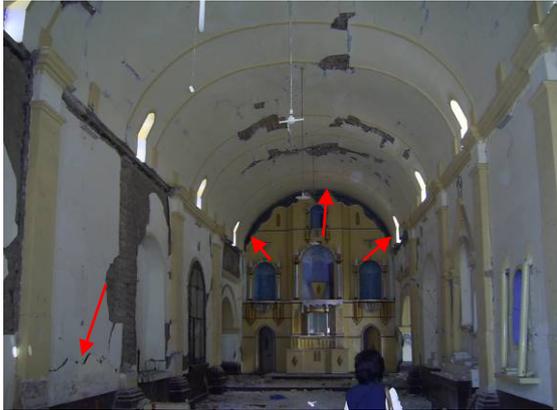
- a) Horizontal cracks on the lateral walls at about 1/3 of their total height (Figure 25a). These cracks can even break through the earthen pilasters (Figure 25b), causing the walls to collapse.
- b) Diagonal cracks on some of the lateral walls.
- c) Detachment of the choir (Figure 25c) from the altar's wall (parallel to the façade) and the church's lateral walls and cylindrical vault ceiling (Figure 25a).
- d) Detachment of the towers from the rest of the church (Figure 25d).
- e) Appearance of vertical cracks and fissures on the church towers (Figure 23a, 23d and 25d).
- f) Humidity related damage (Figure 25e).

a) Detachment of the main altar

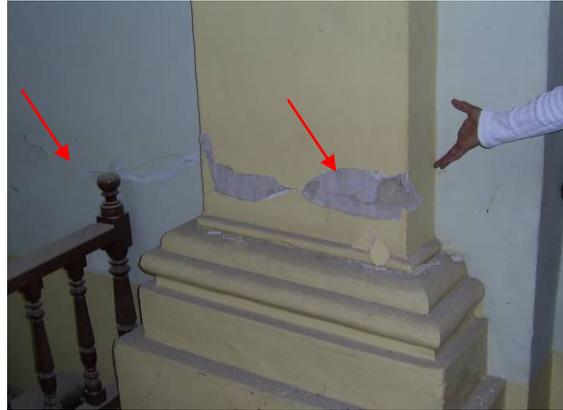
b) Horizontal crack in pilaster

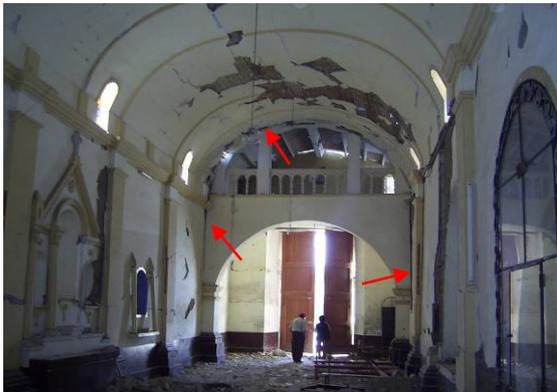
c) Detachment of the choir from the vault

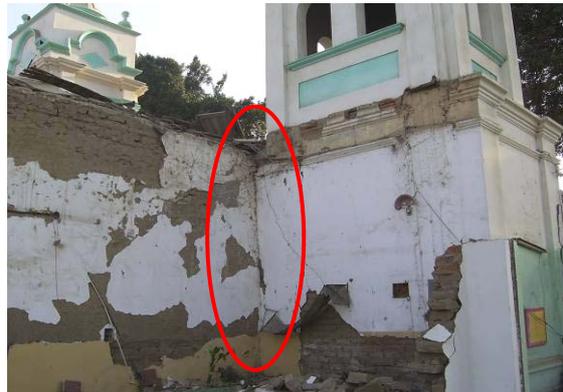
d) Vertical cracks on the intersection between the tower and walls

One of the most common failures in the churches occurred in the intersection between the towers and the main nave. Due to the difference between their fundamental vibration periods, the towers experience a dynamic behaviour different to the main body of the church. The separation (vertical crack) between the façade and the lateral walls (which support the vaulted ceiling) was also a common damage experienced in churches.

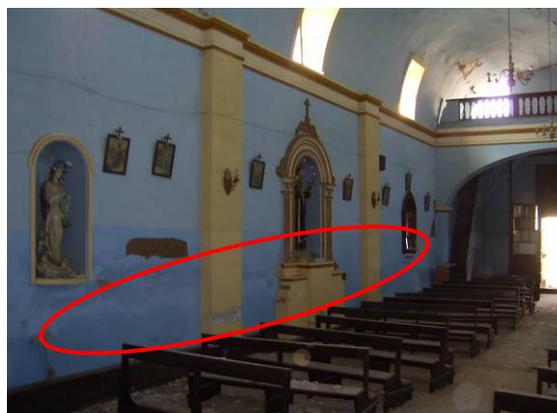
e) Humidity related damage

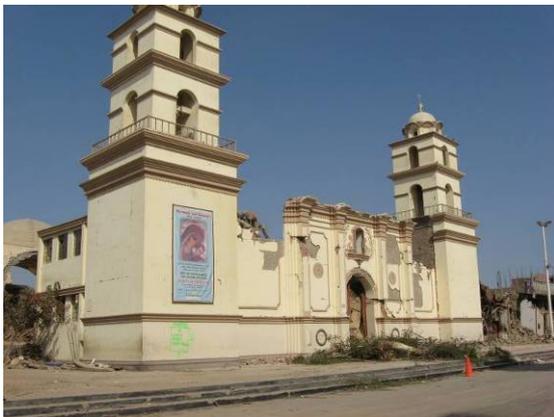
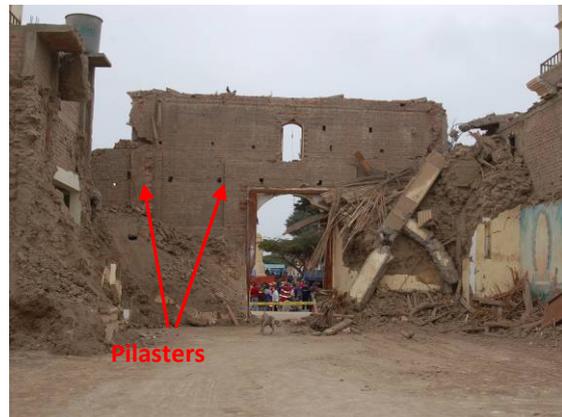
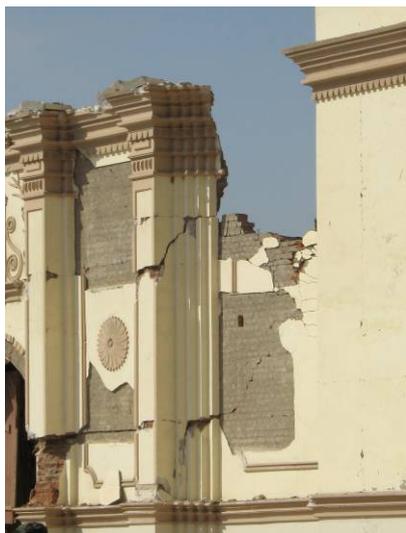
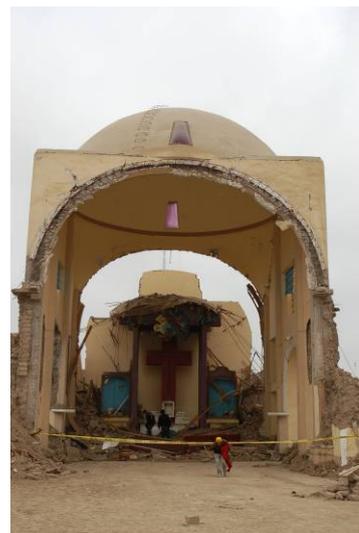
Figure 26.- Church “San Clemente” (Pisco)

This church dates back to the XVIII century. Its façade was constructed using fired clay bricks masonry (Figure 26a) and its most outstanding feature were the two 4-storey high towers and 4 pilasters (that simulated columns) located equidistantly from the main entrance to the church (Figure 26b, 26c).

The church’s lateral walls were built using adobe. The church had a cylindrical vaulted ceiling that was constructed using wooden arches and crushed cane covered by a mud and gypsum stucco. The roof rested on the lateral walls and the main altar’s wall had been reinforced using concrete frames. This reinforcement was probably a latter addition to the structure, most likely done during a more recent restoration of the church (Figure 26d).

There were 300 people attending a mass when the earthquake happened. About half of them died when the roof and walls collapsed. It is possible that the church’s collapse initiated with the cracking and overturning of the lateral walls, to which the roof followed.

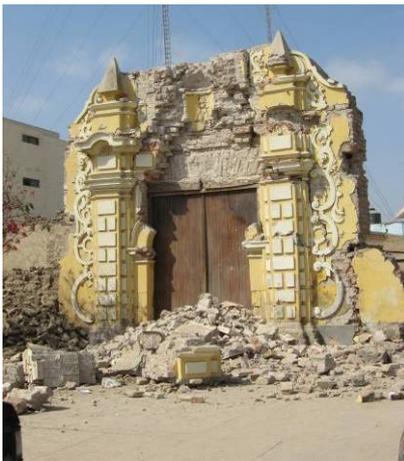
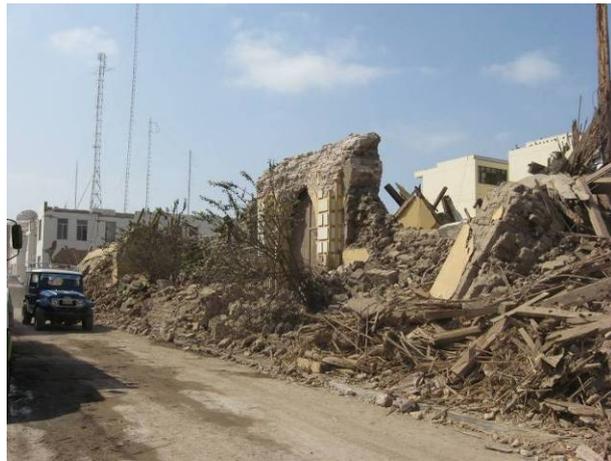
Figure 27. Church “Compañía de Jesús”, Pisco

This church built in Baroque style in the XVII century (Figure 27a and 27b) had brick and adobe walls and, like previous churches, had a cylindrical vaulted ceiling. This church, however, presented opening in the intersections between the walls and the inner arches (Figure 27b). As shown in Figure 27c and Figure 27d, the church suffered from a complete collapse during the earthquake. As part of the emergency works that took place in the city, this church had to be completely demolished.

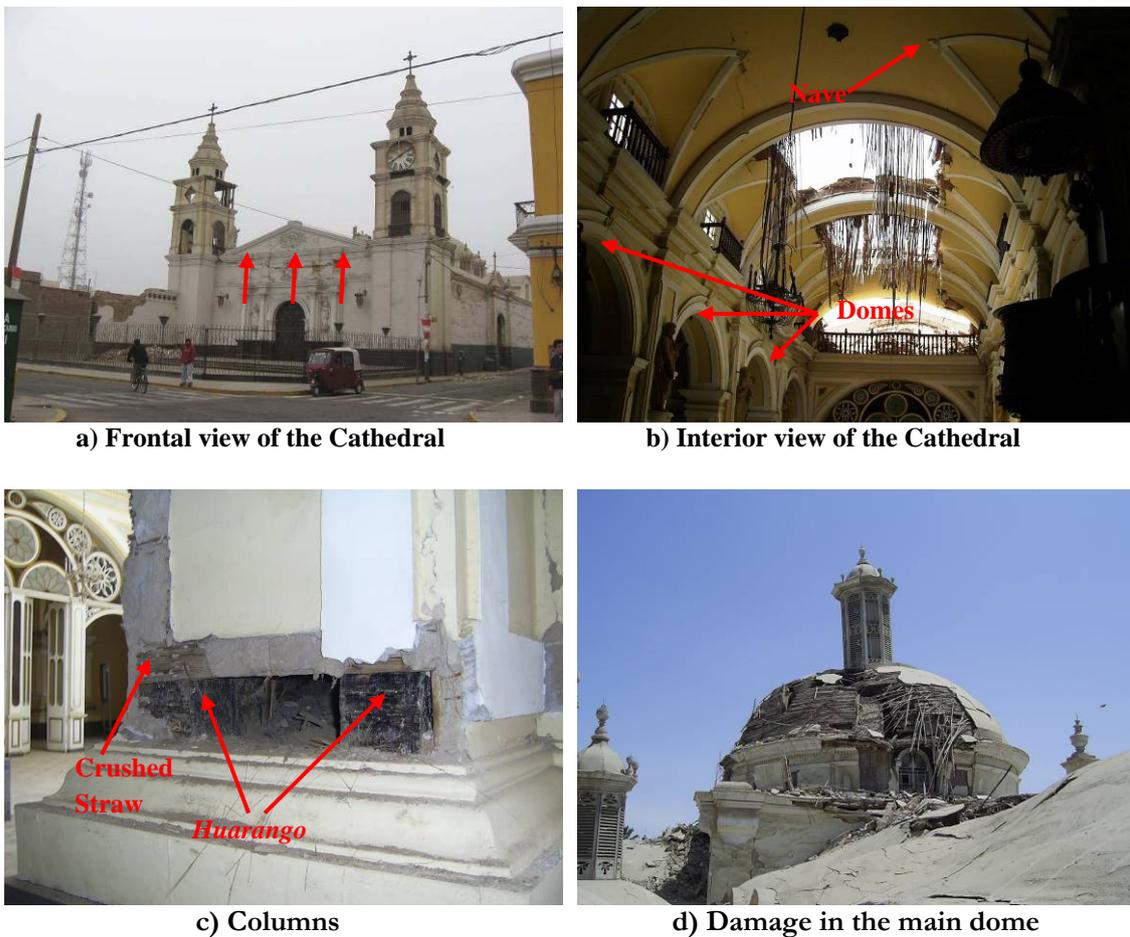
Figure 28.- Ica's Cathedral

The earthquake caused damage on both towers, as well as the partial collapse of the triangular pediment. It also caused fissures on the ceiling, in addition to its partial collapse.

Damage was also suffered by the domes (Figure 28d) and the choir. Vertical and diagonal cracks appeared on the inner earthen walls, the plaster on the columns came off and vertical cracks appeared on the intersection of the right tower and the lateral wall.

Most of the crushed cane in the columns and the vertical canes that were a part of the choir's *quincha* structure are rotten. The restorations that had been made using cement on the mouldings have completely fallen off. Nevertheless, the majority of the plaster mouldings have stayed in place due to their internal cane framework.

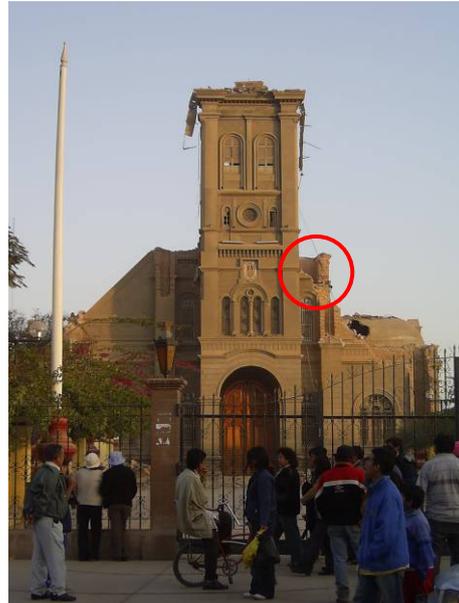
b) Post-earthquake façade

The earthquake caused the collapse of all the three towers (Figure 29b). The main tower collapsed inside the church, causing main vault's partial collapse (Figure 29d). The vault

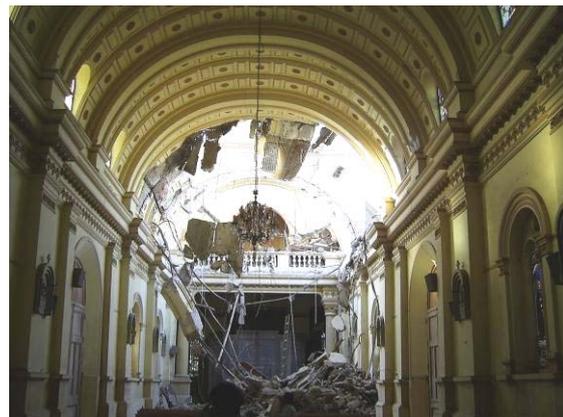
d) Interior view of the church

was supported by two lateral walls that haven't completely collapsed, but that present diagonal fissures.
