## **SEISMIC REINFORCEMENT OF ADOBE HOUSES USING EXTERNAL POLYMER MESH**

**Marcial BLONDET<sup>1</sup>, Daniel TORREALVA<sup>1</sup> Julio VARGAS<sup>1</sup>, José VELASQUEZ<sup>2</sup> and Nicola Tarque<sup>2</sup>**

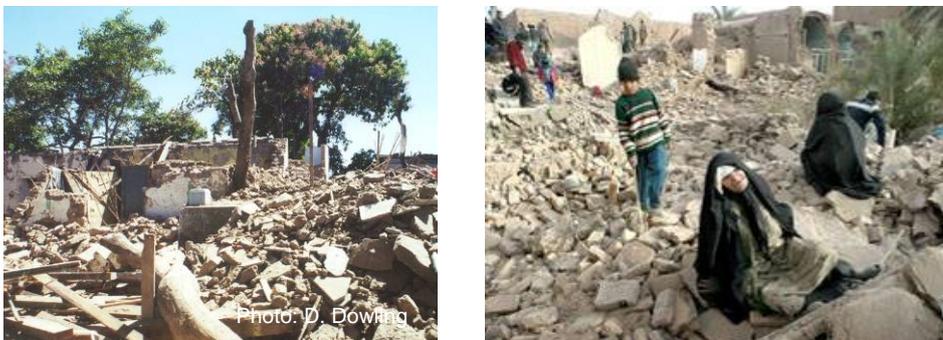
Figure1. Destruction of adobe houses in El Salvador (2001) and in Iran (2003).

Sun dried mud blocks, or adobes, are one the oldest and more widely used building materials in the world. Adobe is still used in many developing countries because soil is easily available and self-construction with this material is relatively simple. Furthermore, adobe dwellings have excellent thermal and acoustic characteristics. The seismic performance of vernacular adobe dwellings, however, is extremely poor. Every significant earthquake that has occurred in regions where adobe construction is common has produced tragic loss of life and considerable material damage (Fig. 1).

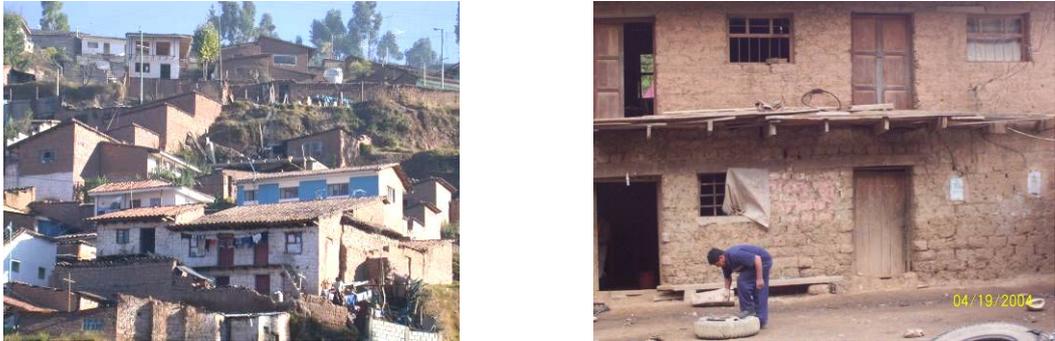
Figure 2. “Modern” adobe houses in Cusco, Peru.

The high seismic vulnerability of adobe masonry is due to a perverse combination of its mechanical properties: relatively high density, extremely low tensile strength, and brittle failure mode. The problem is made worse because most “modern” vernacular adobe houses are built without technical assistance, and thus with poor construction quality, and they tend to imitate the architectural features of clay masonry buildings: several stories, thin walls, large openings, and irregular configurations (Fig. 2).

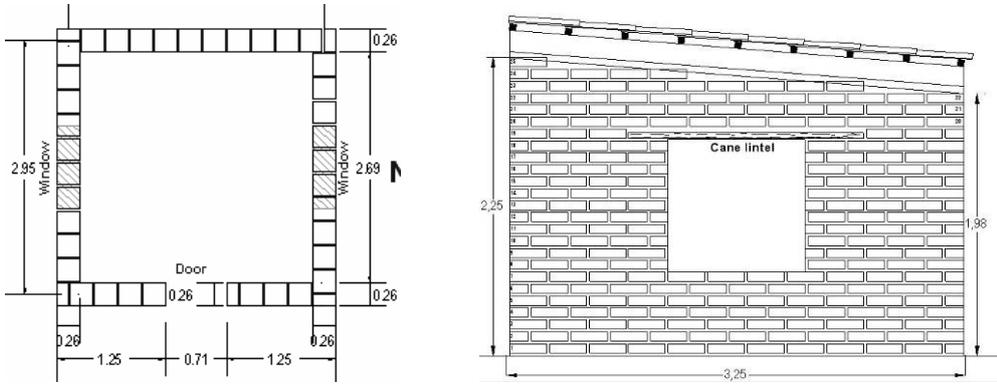
Figure 3. Plan view and elevation of adobe models (Dimensions in m)

The project described in this paper consisted of the seismic testing of five full-scale adobe housing models using the unidirectional PUCP shaking table. The adobe models had the configuration and overall dimensions shown in Fig. 3 below.

The adobe models consisted of four walls 3.21 m long, variable height, and 0.26 m thickness. The longitudinal walls (parallel to the direction of shaking) included a central window opening. The front transverse wall had a door opening and the taller back wall did not have any openings. They were reinforced with different amounts

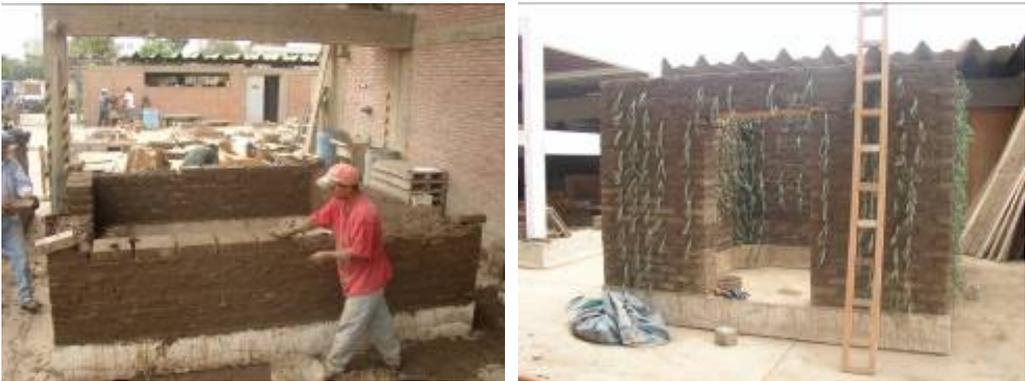
Figure 4. Construction of adobe models

All models were built using traditional techniques, representative of seismically vulnerable adobe construction in Peru. The adobe blocks were fabricated with soil, coarse sand and straw in proportion 5:1:1. They measured 65x250x250 mm and were joined with mud mortar made with soil, coarse sand and straw in proportions 3:1:1. Each specimen was built over a reinforced concrete foundation ring beam, which also served to anchor the specimen to the shaking table and as support during transportation from the construction yard to the laboratory. A wooden crown beam was placed on top of all specimens, except model M000, to integrate all walls and to transmit the roof weight to the longitudinal walls.

The roof consisted of wooden joists covered with cement tiles. Each specimen weighed around 140 kN. Both windows had flexible lintels made of cane rods, except model M100-T12, which had wooden lintels. The flexible lintels were used as an attempt to avoid local failure, observed in previous tests, caused by the impact of the stiff wooden lintel against the earthen walls. Masons with experience in building adobe houses were hired to fabricate the adobe blocks and to build the housing models. The reinforcement provided consisted of bands of polymer mesh tied to both sides of the walls with plastic string threaded through the walls. Figure 4 shows two models under construction. Observe the plastic strings that have been left across the walls of one of the models.

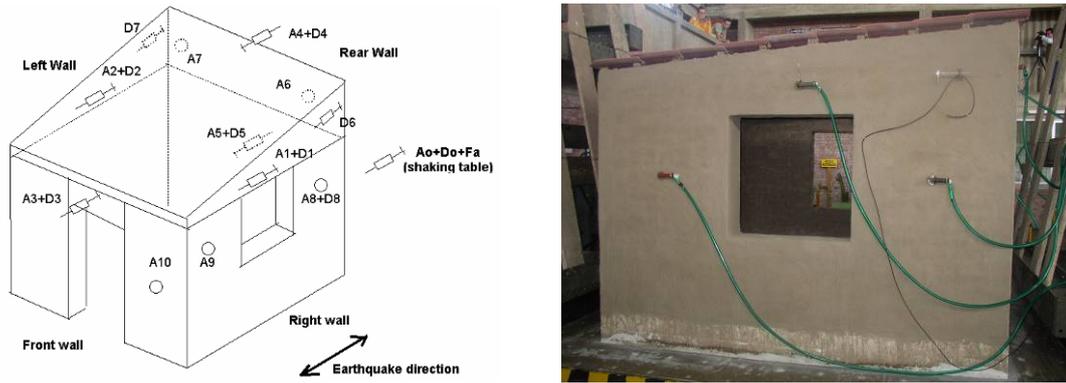
a) Instrumentation schematics

b) Instruments on M000's left wall

Figure 5. Model instrumentation

Instrumentation consisted of accelerometers and displacement transducers (LVDTs). Actuator pressure differential (proportional to force), and table acceleration and displacement were also recorded. See Fig. 5 below.

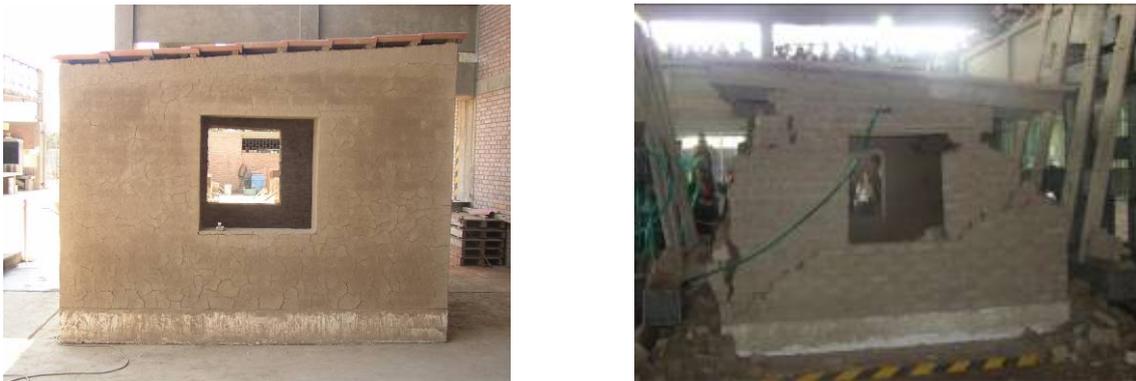
Figure 6. Unreinforced model M000

This unreinforced model represented a typical vernacular adobe building. During test phase 1 (30mm) diagonal cracks appeared on both longitudinal walls, and the wooden beams supporting the roof detached from the walls. In phase 2 (80mm) important vertical cracks appeared at the corners of the transverse walls, which collapsed during phase 3 (Fig. 6, right). This type of failure is representative of that of vernacular earthen structures: a few large cracks divide the walls in several pieces, which afterwards fail independently.

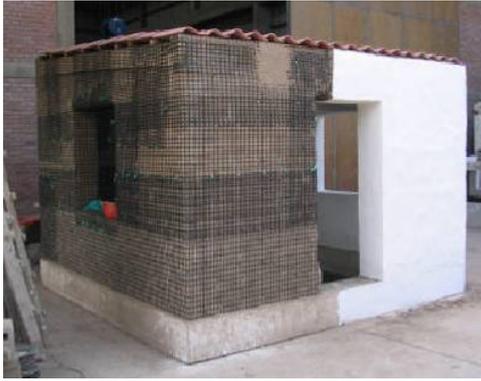
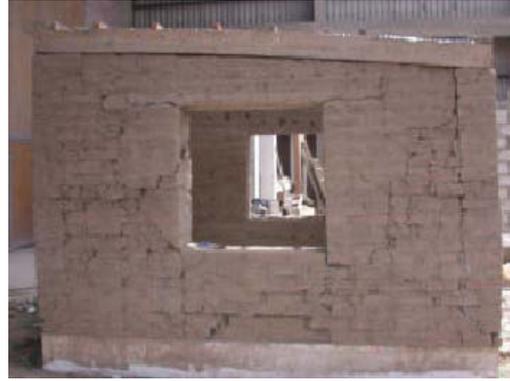
Figure 7. Reinforced model M100-T12.

Model M100-T12 was completely covered by geogrid on both sides of the walls (Fig. 7). During the first test phases the model moved almost as a rigid block. It remained in the elastic range until phase 3 (60 mm). In phase 4 (80 mm), small cracks appeared in the walls. The cracks were more visible in the mud-plastered right side. In phase 5 (100 mm) the right wall slid from its base almost as a rigid body, without any significant damage. The left wall showed large displacements and significant cracking. Phases 6 and 7 (both 120 mm), caused significant torsional response, sliding at the base, and additional cracking in the non-plastered walls. After the test the mud plaster was removed, revealing the plastered walls suffered very minor damage. This indicates that the mud plaster has an important contribution to the strength and stiffness of the adobe walls.

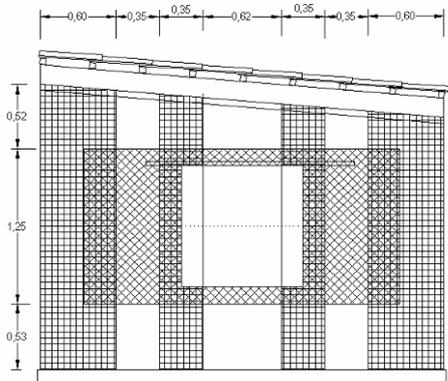
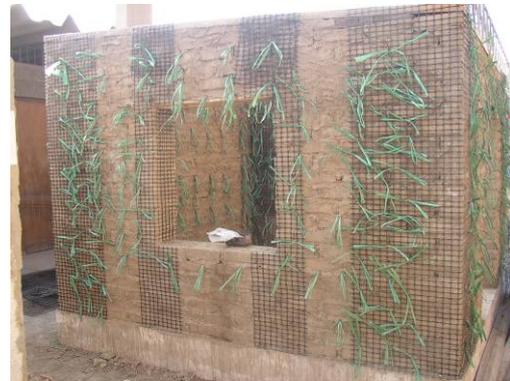
Figure 8. Model M075-T11

This model was partially reinforced with geogrid, which covered around 75% of the total wall surface (Fig. 8).

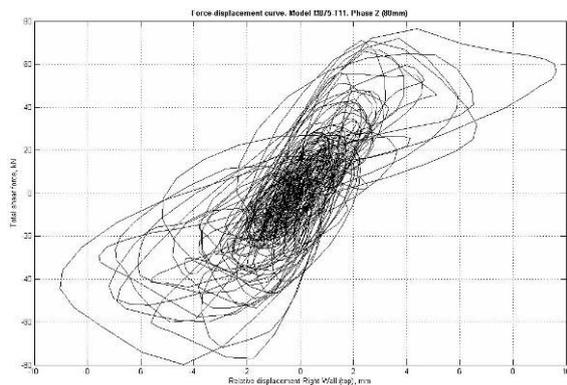
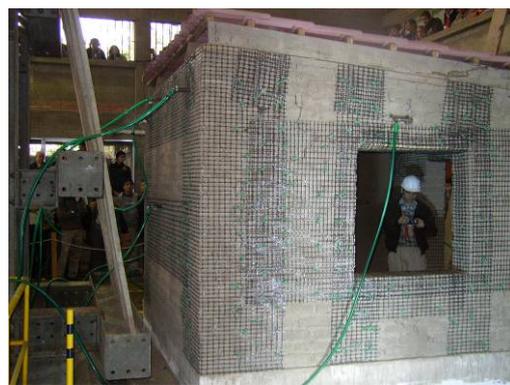
Figure 9. Seismic behavior of model M075-T11

The first cracks appeared during phase 2 (80mm), indicating the start of significant nonlinear response, as shown in the force-displacement curves (Fig.9, left). The cracking pattern was typical: vertical cracks at the corners and diagonal cracks at the longitudinal walls (Fig. 9, right).

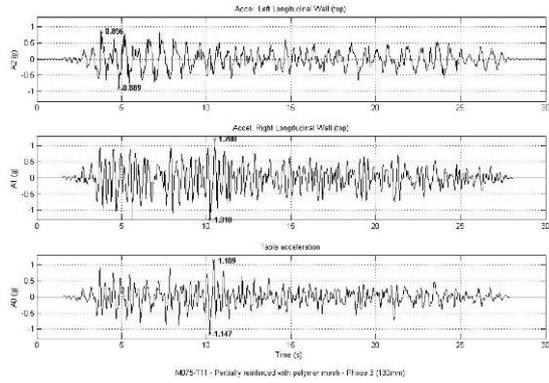
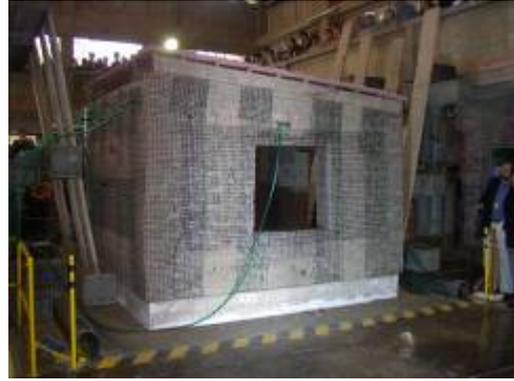
Figure 10. Seismic behavior of model M075-T11 until phase 3

Wall cracking continued in phase 3 (130 mm), but the building kept its integrity because the mesh reinforcement was able to provide displacement control and a more uniform distribution of cracking of the walls. When the mesh was removed after testing, it could be verified that it was deformed or broken in critical locations, such as where it was nailed to the crown beam. Figure 10 (left) clearly shows that the response of the mud-plastered right wall had a higher frequency than that of the unplastered left wall, which confirms that the mud plaster over the external reinforcement substantially increased the stiffness and the strength of the adobe walls.

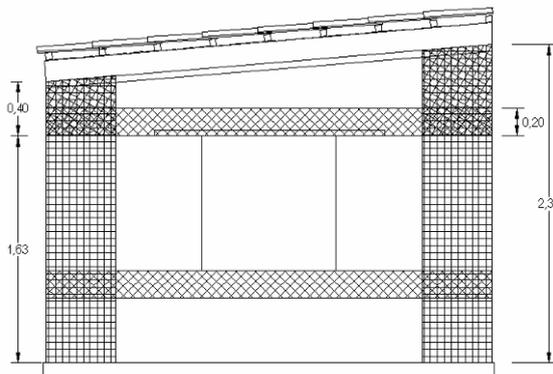
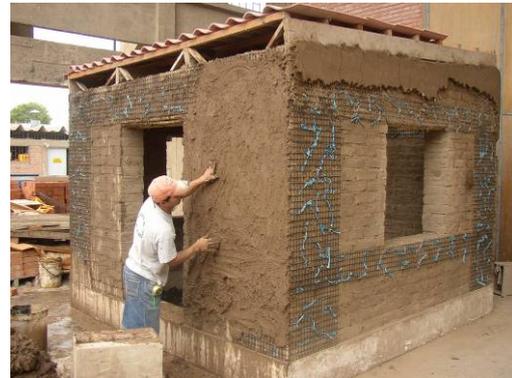
Figure 11. Reinforcement arrangement and construction of model M050-T11.

In order to reduce the amount of polymer mesh employed, geogrid reinforcement was placed only in the most critical regions of model M050-T11. As shown in Fig. 11, vertical bands were placed at wall corners and horizontal bands at the top and bottom of the window openings. The reinforcement covered around 50% of the total wall surface.

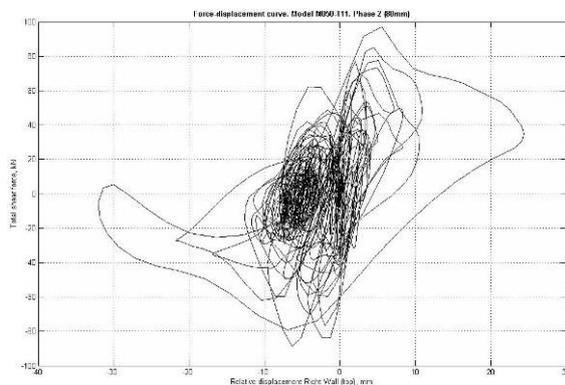
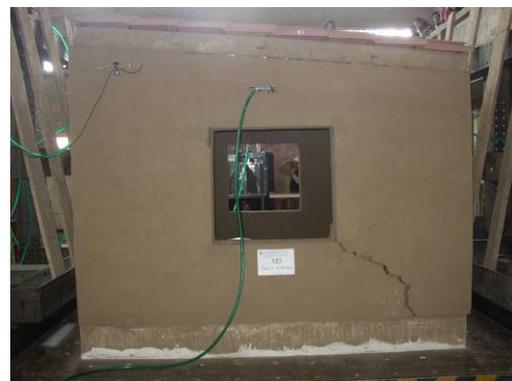
Figure 12. Seismic behavior of model M050-T11

As for the previous model, the first cracks appeared in phase 2 (80mm). Figure 12 shows that, due to the lesser amount of reinforcement provided, cracks were much larger and consequently, nonlinear response was more pronounced.

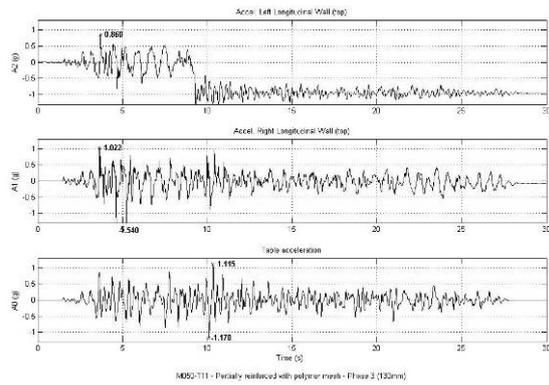
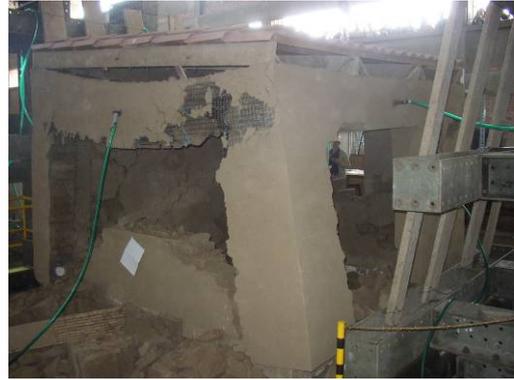
Figure 13. Seismic behavior of model M050-T11 until phase 3

During the strong shaking of phase 3 ( $D = 130$  mm) the model suffered significant damage. Although collapse was averted, the brittle failure of the longitudinal walls showed that the amount of reinforcement provided in those walls was insufficient (Fig. 13).

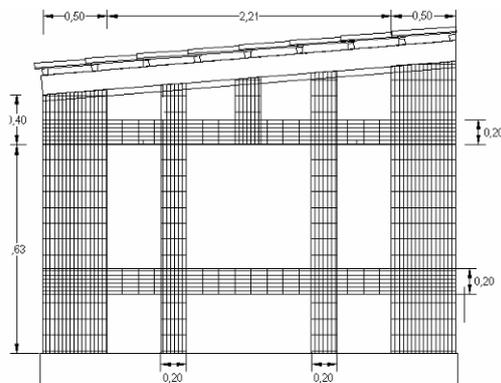
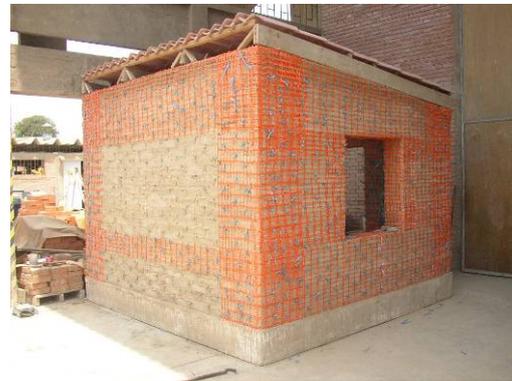
Figure 14. Reinforcement arrangement and finished model M080-E.

Since geogrid is quite expensive in Peru, it was decided to study the use of a cheaper plastic mesh, usually employed as a soft safety fence in construction sites. The left wall was completely covered and the right wall was partially covered, as shown in Fig. 14. Around 80% of the wall surface was thus reinforced.

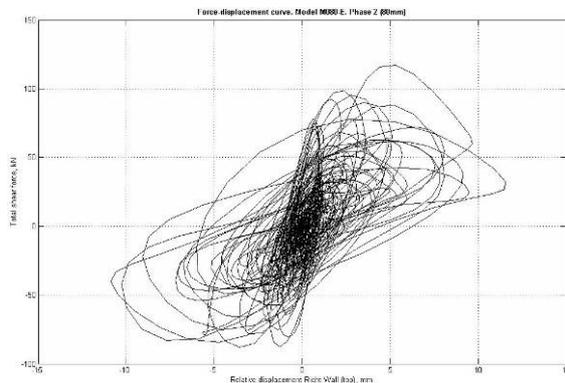
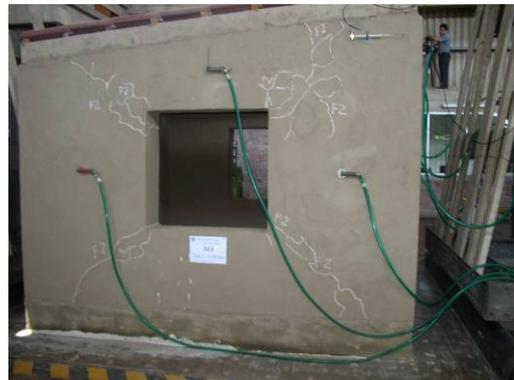
Figure 15. Seismic behavior of model M080-E until phase 2

During phase 1 (30mm) the model showed an elastic behavior and remained practically uncracked. Some sliding was noticed at the base of the walls. In phase 2 (80mm) diagonal cracking started from the corner of the windows of both longitudinal walls (Fig. 15). Also, some mud plaster fell apart. The transverse wall also showed significant cracking, but did not collapse.

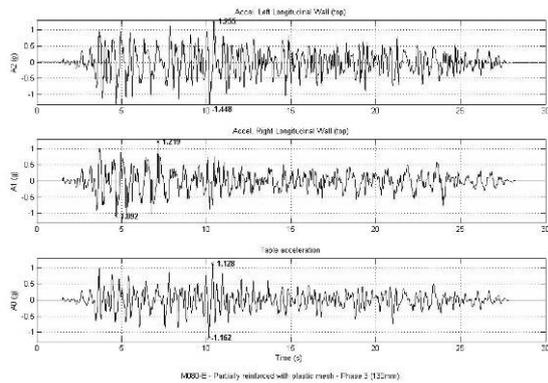
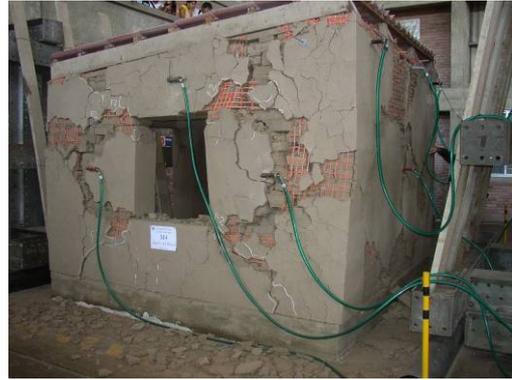
Figure 16. Seismic behavior of model M080-E until phase 3

In phase 3 the model suffered significant damage. The left wall (totally reinforced) had many uniformly distributed cracks. The right wall (partially reinforced) had fewer, larger cracks and was practically broken into several pieces, held together by the plastic mesh (Fig. 16). The mesh was deformed and broken in several places, indicating that the amount provided was barely adequate.
