## **Available low-cost technologies to improve the seismic performance of earthen houses in seismic areas**

**Authors** M. Blondet, J. Vargas and N. Tarque  
**Address** Catholic University of Peru, Department of Engineering. Avenida Universitaria 1801, San Miguel, Lima 32, Peru  
**E-Mail** mblondet@pucp.edu.pe

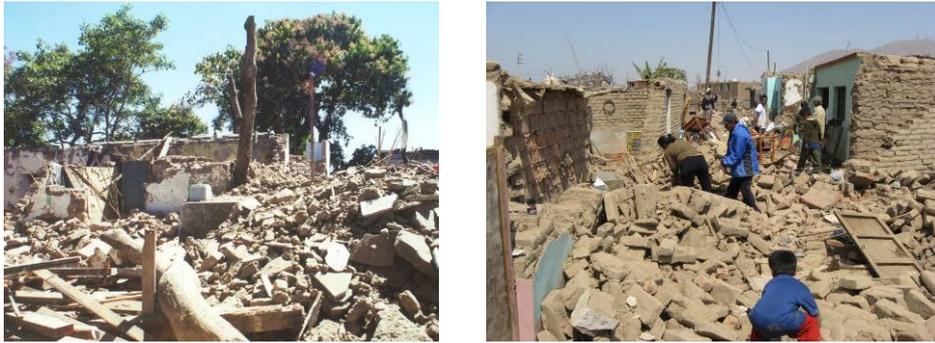
**Figure 1.** Destruction of adobe houses in El Salvador (2001, Photo: D. Dowling) and Pisco (2007)

The high seismic vulnerability of earthen buildings is due to a perverse combination of the mechanical properties of their walls: earthen walls are dense and heavy, have extremely low tensile strength and they fail in a brittle fashion, without any warning. As a consequence, every significant earthquake that has occurred in regions where earthen construction is common has produced tragic loss of life and considerable material damage (Fig. 1).

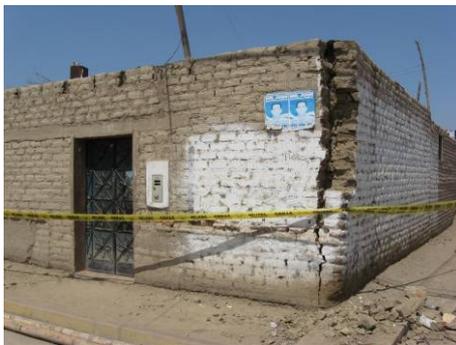
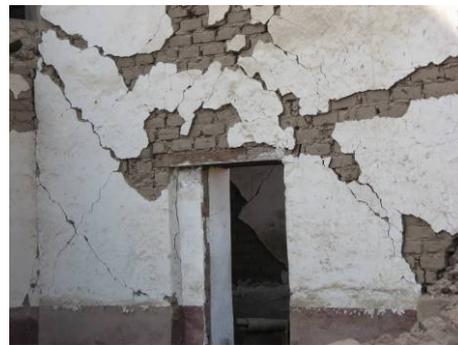
Vertical crack at corner of front wall

Diagonal cracks

**Figure 2.** Seismic cracks in adobe houses (Pisco earthquake 2007)

During earthquakes the ground shakes in all directions and generates inertia forces that the construction material should be able to withstand. Since the tensile strength of adobe masonry is very low (and much lower than its compressive strength), significant cracking starts in the regions subjected to tension. Seismic forces perpendicular to the walls produce out-of-plane bending, and vertical cracking starts at the lateral corners of the walls, where the tensile stresses are higher. Large vertical cracks that separate the walls from one another are thus produced (Fig. 2, left). Front walls are usually the first to collapse in an earthquake, overturning onto the adjacent street. Lateral seismic forces acting within the plane of the walls generate shear forces that produce diagonal cracks, which usually follow stepped patterns along the mortar joints. The diagonal cracks often start at the corners of doors and windows, due to the stress concentration at these locations (Fig. 2, right). If the seismic movement continues after the adobe walls have cracked, the wall breaks in separate pieces, which may collapse independently.

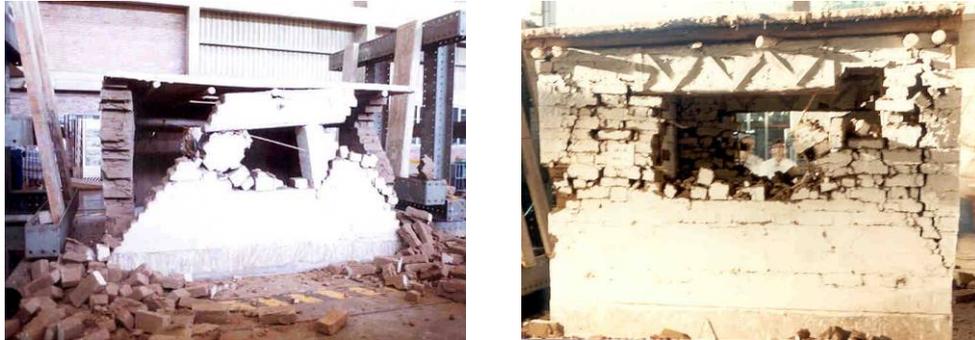
**Figure 6.** Adobe models after seismic tests. L: Unreinforced. R: Reinforced with cane

This reinforcement system has demonstrated excellent response in full-scale shaking table tests (Blondet et al. 1988). Figure 6 shows the collapse of a full scale adobe house model subjected to simulated seismic motion (left). During a similar test, the model reinforced with an internal cane mesh suffered significant damage, but did not collapse. The main limitation of this system is the fact that cane is not available in all seismic regions. Even in areas where cane is produced, it is practically impossible to obtain the required quantity for a massive construction program.

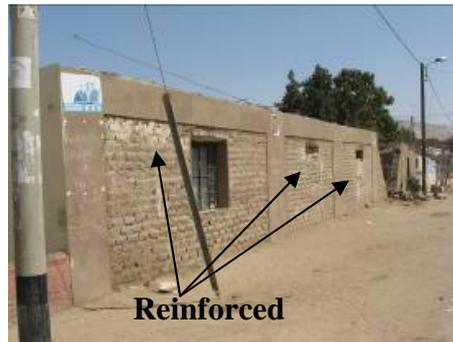
Placing the mesh on the wall.

Reinforced house (Pisco earthquake 2007)

**Figure 7.** External wire mesh reinforcement

This technique consists of nailing wire mesh bands against the adobe walls and then covering them with cement mortar. The mesh is placed in horizontal and vertical strips, following a layout similar to that of beams and columns (Fig. 7).

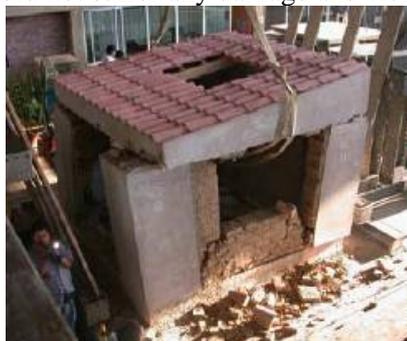
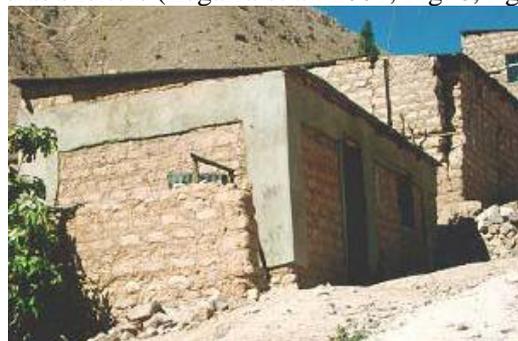
Reinforced model after seismic test

Reinforced house (Arequipa earthquake 2001)

**Figure 8.** Adobe buildings with external wire mesh reinforcement

This system provided significant additional strength to adobe models under earthquake simulation tests. Although the performance of the models was adequate during moderate and severe shaking, the mode of failure was brittle during strong tests (Fig. 8, left). During a moderate earthquake in Peru, while surrounding houses were severely damaged or destroyed, houses reinforced with this system did not suffer any damage and were used as shelters (Zegarra et al. 2001, Fig. 8, right).

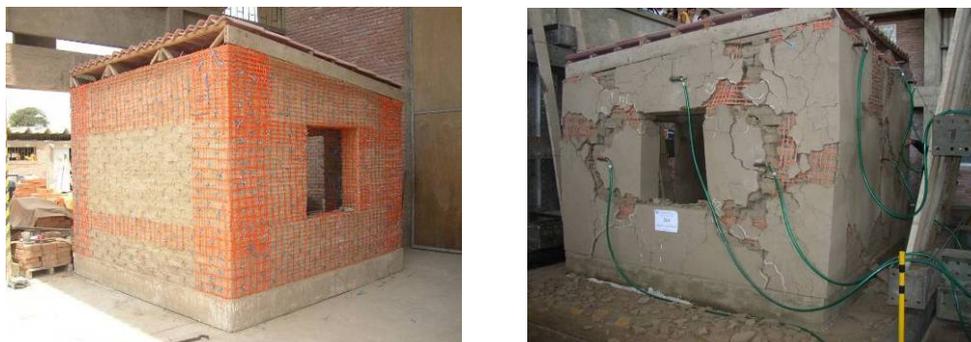
**Figure 10.** Adobe model reinforced with plastic mesh

Since geogrid polymer mesh is quite expensive in Peru, it was decided to study the use of a cheaper plastic mesh, usually employed as a soft safety fence in construction sites. The adobe model shown in Fig. 10 was reinforced with bands of plastic mesh located in the regions where most damage was expected on the adobe walls. The plastic mesh bands were tied to the walls with plastic string placed across the walls during construction. After a strong shaking test, the adobe walls were broken into several large pieces, which were held together by the plastic mesh. The mesh was deformed and broken in several places, indicating that the amount provided was barely adequate. It is clear, however, that although the building suffered significant damage, collapse was averted.
