## Observed behaviour of earthen structures during the Pisco earthquake (Peru)

M. Blondet<sup>1</sup>, J. Vargas<sup>2</sup> and N. Tarque<sup>3</sup>

### ABSTRACT :

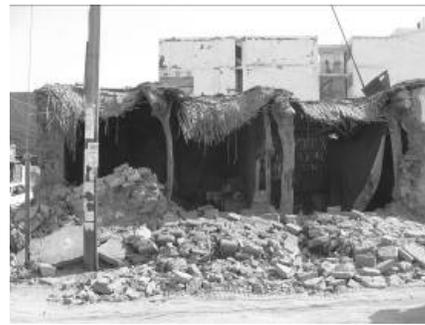
b) Eucalyptus trunks used as columns

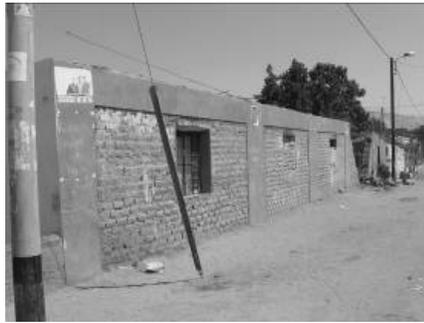
a) Reinforced building

Between November 2005 and April 2006, the National Service for the Construction Industry (SENCICO) carried out a training program in which participants were instructed on the construction of three adobe buildings with seismic reinforcement (the first two houses were 1-story high while the second one was 2-stories high) in Lunahuana and Pacaran, in the province of Cañete (north of Chincha, Figure 2). The reinforcement used into these houses consisted of internal cane mesh and a perimeter wooden crown beam. The foundation of the house was built using cyclopean concrete and the plinth wall with simple concrete. The second floor of the third house was built using prefabricated *quincha* panels. The post-earthquake evaluation of the houses shows that the buildings that were 1-story high didn't suffer from any damage while the only consequence of the earthquake in the 2-storey high dwelling was the detachment of some of the mud plaster from the *quincha* panels (SENCICO 2008).

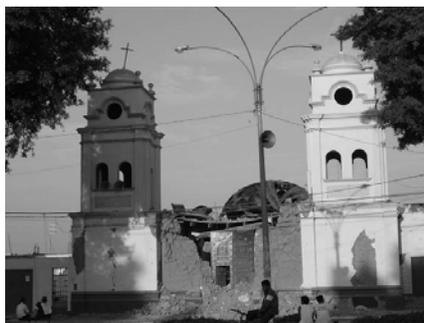
a) Front view

Almost all of the churches and historical landmarks that had been built with soil and bricks suffered heavy damage or even collapsed as a consequence of the earthquake. According to the National Institute of Culture (INC), 32% of the historical and cultural monuments in Ica have completely collapsed, 23% are under strong risk of collapsing, 26% are under moderate risk and 19% show minor damage to their structure (24 Horas Libres, 2007). Most of the earthen churches in Ica have one or two towers that are about 3 to 4 story high as part of their façade, lateral adobe walls (1,20 m thick and 5 to 6 m high approximately), and a roof consisting of a cylindrical vault constructed using wooden arches, crushed cane, straw mats and a mud coat on the outside and stucco on the inside (Figure 10).

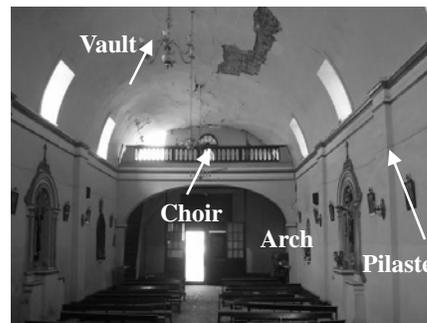
b) Internal view

The plan view of the church is cross-shaped. The choir area (which is 2-story high) is located right behind the church's main door and the altar is on the back of the church. The church's lateral walls have pilasters built approximately every 4 m that simulate columns (Figure 10b).

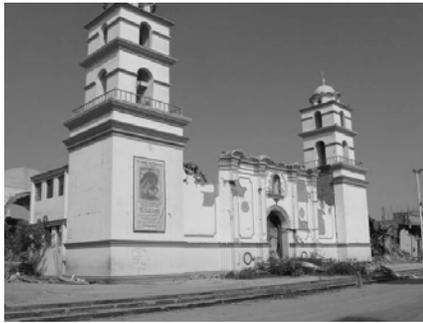
a) Frontal view of the church

This church dates back to the XVIII century. Its façade was constructed using fired clay bricks masonry (Figure 12a) and its most outstanding feature were the two 4-storey high towers and 4 pilasters (that simulated columns) located equidistantly from the main entrance to the church (Figure 12b). The church’s lateral walls were built using adobe. The church had a cylindrical vaulted ceiling that was constructed using wooden arches and crushed cane covered by a mud and gypsum stucco. The roof rested on the lateral walls and the main altar’s wall had been reinforced using concrete frames. This reinforcement was probably a latter addition to the structure, most likely done during a more recent restoration of the church. There were 300 people attending a mass when the earthquake happened. About half of them died when the roof and walls collapsed. It is possible that the church’s collapse initiated with the cracking and overturning of the lateral walls, to which the roof followed.

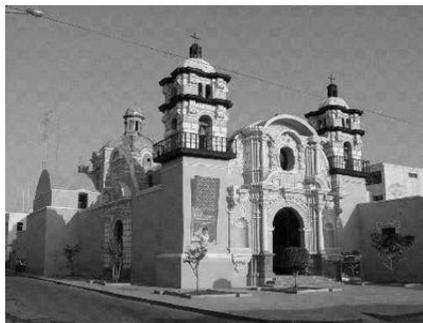
a) View of the church before the earthquake

This church built in Baroque style in the XVII century (Figure 13a) had brick and adobe walls and, like previous churches, had a cylindrical vaulted ceiling. This church, however, presented opening in the intersections between the walls and the inner arches. As shown in Figure 13b, the church suffered from a complete collapse during the earthquake.
