# BEHAVIOUR OF EARTHEN STRUCTURES DURING THE PISCO EARTHQUAKE (PERU)

Marcial Blondet<sup>1</sup>, Julio Vargas<sup>2</sup> and Nicola Tarque<sup>3</sup>

## ABSTRACT

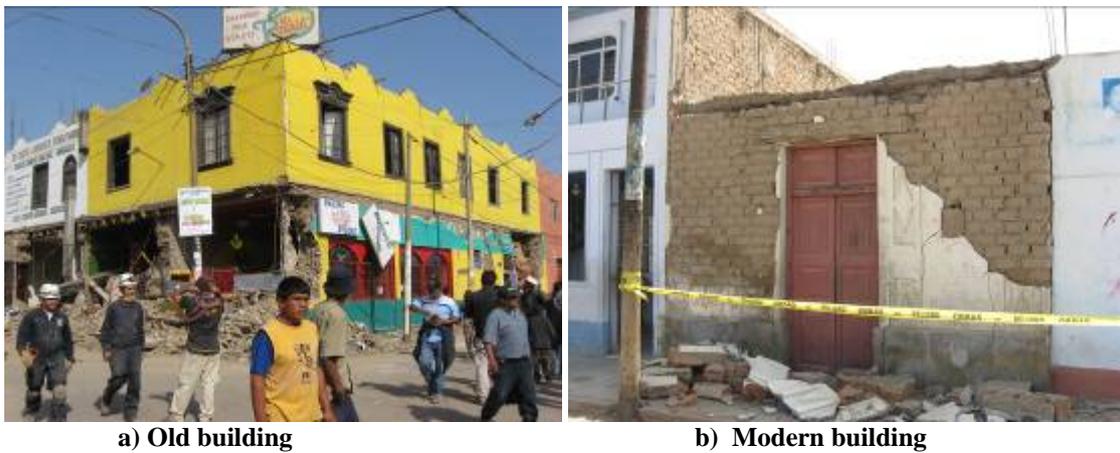
Figure 4. Adobe dwellings

The oldest earthen houses in the area were built more than 50 years ago, and are located in downtown Pisco and Ica. The usual thickness on these buildings' walls tends to range between 0,7 m and 0,8 m thick and about 4 m high. This means that their slenderness ratio (height/width) is below 6. Some of these buildings have used *quincha* panels to create interior independent environments. *Quincha* is a construction method that is widely used in South America, consisting on a wood and cane framework that is then covered with mud or plaster. In some of the older 2-storey high buildings, adobe was used for the construction of the first floor, while the second floor was built using *quincha* (Figure 4a). The more modern adobe buildings, on the other hand (Figure 4b), have thinner and shorter walls (0.25 m and 3 m respectively) and their slenderness ratio is 8 or higher. These buildings don't have *quincha* walls and although most of them are only 1-storey high, a lot of them have interior rooms without a roof.

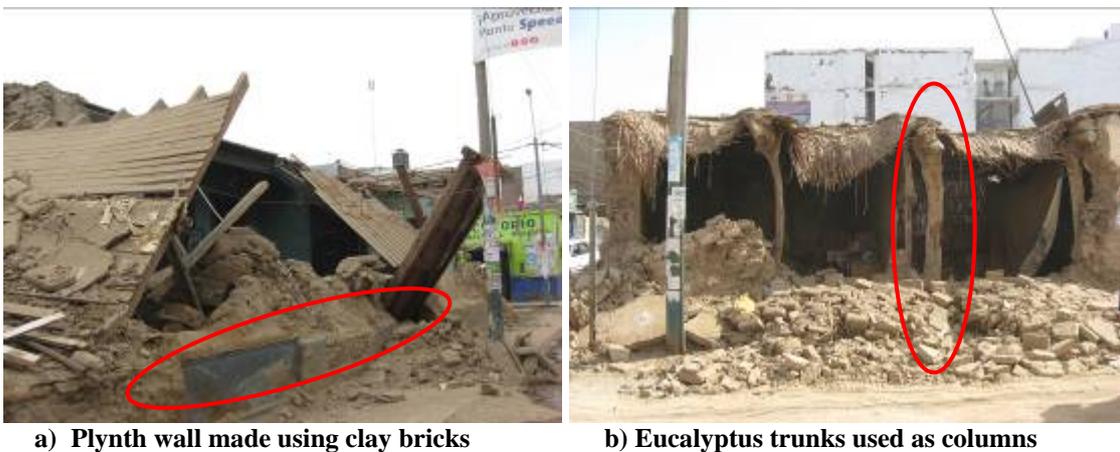
Figure 5. Old adobe dwellings in Ica

The older adobe dwellings surrounding Ica's main square have a 0,8 m high plinth wall made with fired clay bricks (Figure 5a.). The plinth walls on these houses were built to protect the walls from the humidity in the area, as Ica has already suffered several floods in the past. The completed wall is usually 4 m. high and 0,8 m thick. Eucalyptus trunks are sometimes placed within walls to partially bear the roof's weight (Figure 5b).

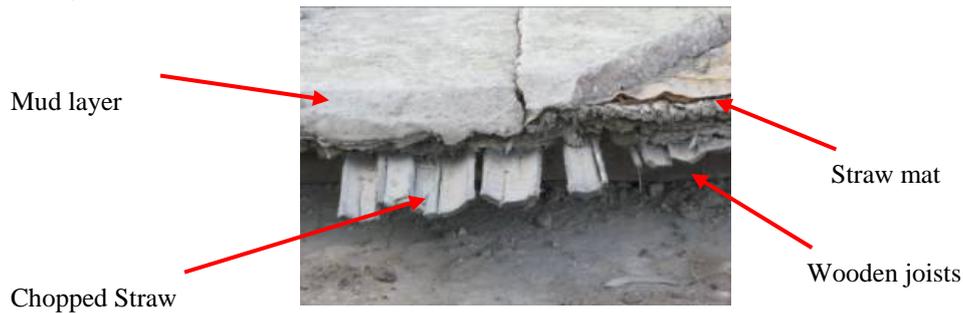
**Figure 6 - Materials used for the roofs**

The roofs of these constructions are built using a of wooden joists framework covered with a first layer of crushed cane, a second layer of straw mats (*esteras*) and finally plastered

with mud (Figure 6). The wooden joists can either be parallel or perpendicular to the façade walls.

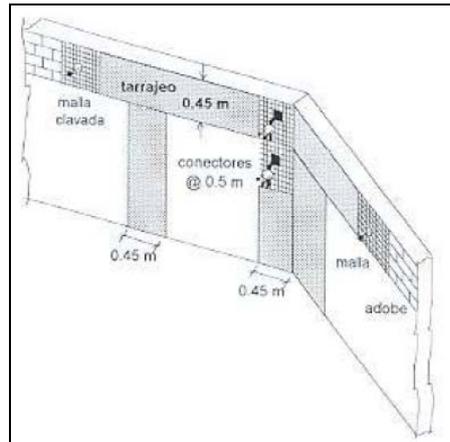
**Figure 17. Detail of the seismic reinforcement (San Bartolomé et al. 1999)**

Between September 1998 and January 1999, a pilot plan was introduced to the CERESIS (South American Regional Center for Seismology) - GTZ (German Cooperation Agency) - PUCP project to reinforce adobe dwellings (San Bartolomé et al. 1999). 19 adobe constructions located in different areas all throughout Peru were reinforced to withstand seismic activity. The reinforcement system consisted on electro-welded steel mesh strips nailed to the walls and covered with cement and sand mortar. Vertical reinforcing strips were added to the walls' intersections and horizontal strips placed on the highest part of the walls (Figure 17).

Two of these reinforced houses are located in the villages of Pachacútec and Guadalupe in Ica. None of these buildings suffered from any damage related to the earthquake. The reinforcement applied to these dwellings prevented the formation of vertical cracks. After the reinforcement was applied to the house in Guadalupe, an enclosure wall was built by its owner without taking any seismic reinforcement considerations into account (Figure 18a). This wall collapsed as observed in Figure 18b.

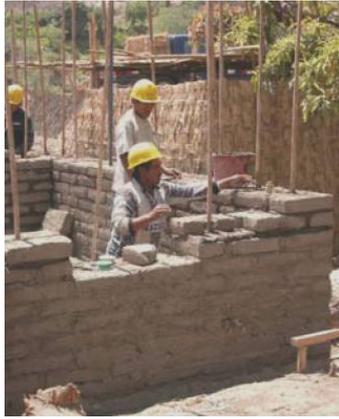
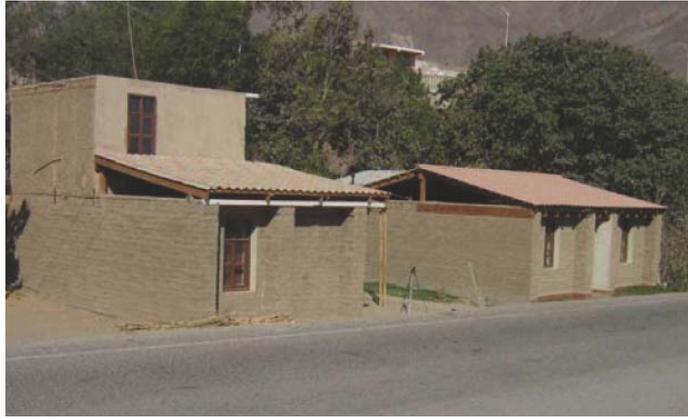
Figure 21. Reinforced adobe houses in Lunahuana and Pacaran (SENCICO 2008)

Between November 2005 and April 2006, the National Service for the Construction Industry (SENCICO) carried out a training program in which participants were instructed on the construction of three adobe buildings with seismic reinforcement (the first two houses were 1-story high while the second one was 2-story high) in Lunahuana and Pacaran, in the province of Cañete (north of Chincha, Figure 3). The reinforcement used into these houses consisted of internal cane mesh and a perimeter wooden crown beam (Figure 21a). The foundation of the house was built using cyclopean concrete and the plinth wall with simple concrete. The second floor of the third house was built using prefabricated *quincha* panels. The post-earthquake evaluation of the houses shows that the buildings that were 1-story high didn't suffer from any damage while the only consequence of the earthquake in the 2-storey high dwelling was the detachment of some of the mud plaster from the *quincha* panels (Figure 21b, SENCICO 2008).

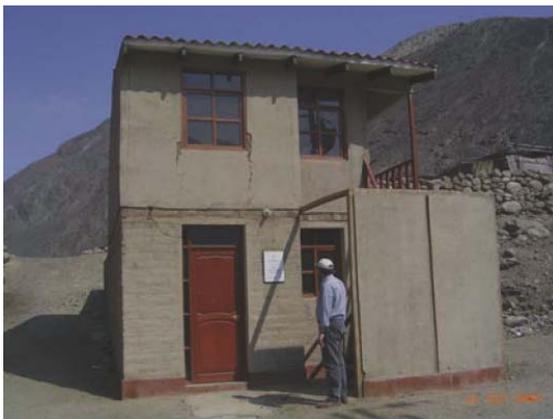
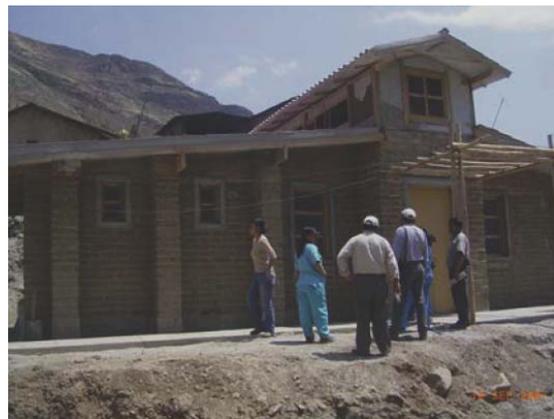
Figure 22.- Reinforced dwellings located in Zuñiga (a) and Huangascar (b) (Taucer et al. 2007)

Figure 22 shows a different group of adobe houses that were built taking seismic precautions into account, applying an internal cane mesh with a wooden perimeter crown beam as reinforcement. These houses were built by the Japanese Agency for International Cooperation Agency (JICA). Only minor damage was reported on these constructions after the earthquake, such as the appearance of fissures around the doors and windows of the second floor.

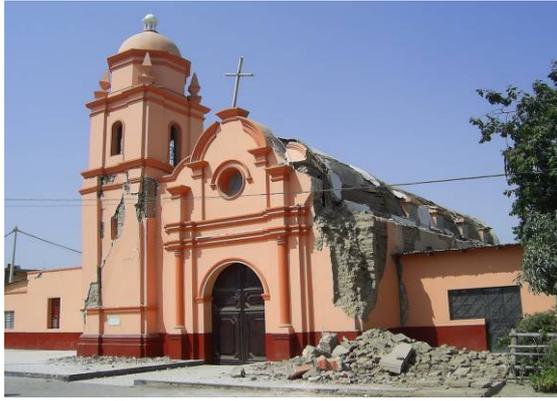
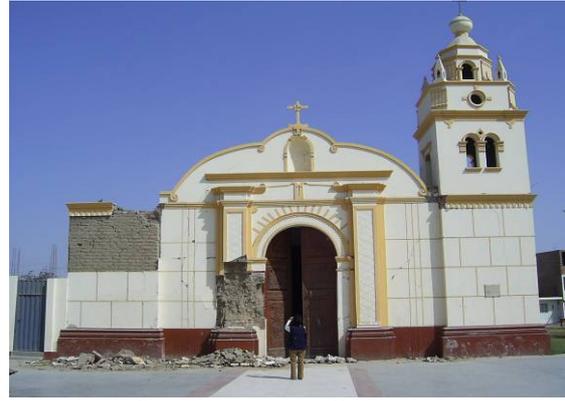
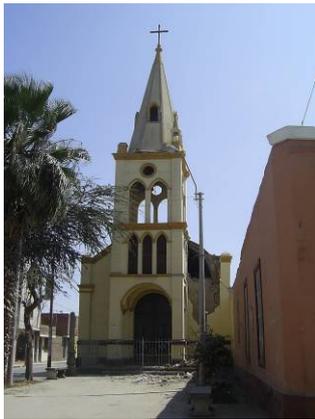
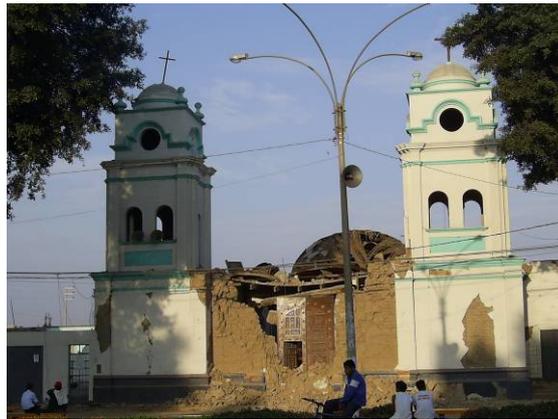
Figure 23. Earthen churches located in Ica

Most of the earthen churches in Ica have one or two towers that are about 3 to 4 story high as part of their façade, lateral adobe walls (1,20 m thick and 5 to 6 m high approximately), and a roof consisting of a cylindrical vault constructed using wooden arches, crushed cane, straw mats and a mud coat on the outside and stucco on the inside. The churches shown on Figure 23a, 23b and 23c are from the XIX century (according to the parish from the church “San Juan de Dios”).

- a) Horizontal cracks on the lateral walls at about 1/3 of their total height (Figure 25a). These cracks can even break through the earthen pilasters (Figure 25b), causing the walls to collapse.
- b) Diagonal cracks on some of the lateral walls.
- c) Detachment of the choir (Figure 25c) from the altar's wall (parallel to the façade) and the church's lateral walls and cylindrical vault ceiling (Figure 25a).
- d) Detachment of the towers from the rest of the church (Figure 25d).
- e) Appearance of vertical cracks and fissures on the church towers (Figure 23a, 23d and 25d).
- f) Humidity related damage (Figure 25e).

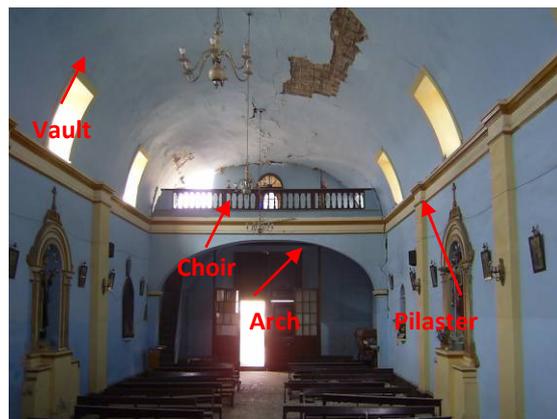
Figure 24. Internal view, from Church "San Juan de Dios"

The plan view of the church is cross-shaped. The choir area (which is 2-story high) is located right behind the church's main door and the altar is on the back of the church. The church's lateral walls have pilasters built approximately every 4 m that simulate columns (Figure 24).

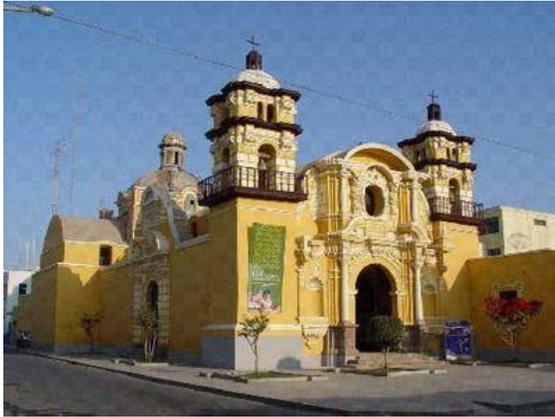
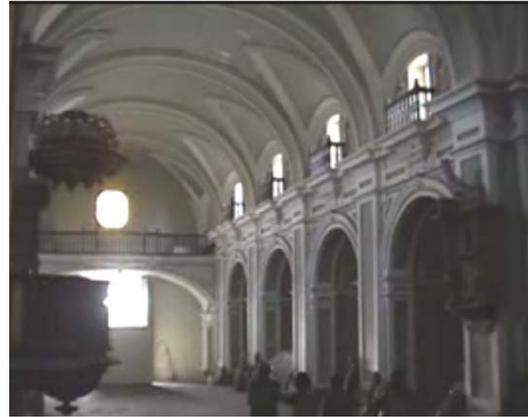
Figure 27. Church “Compañía de Jesús”, Pisco

This church built in Baroque style in the XVII century (Figure 27a and 27b) had brick and adobe walls and, like previous churches, had a cylindrical vaulted ceiling. This church, however, presented opening in the intersections between the walls and the inner arches (Figure 27b). As shown in Figure 27c and Figure 27d, the church suffered from a complete collapse during the earthquake. As part of the emergency works that took place in the city, this church had to be completely demolished.

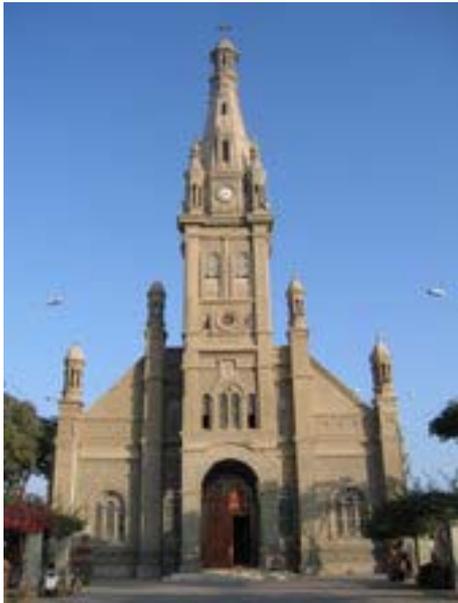
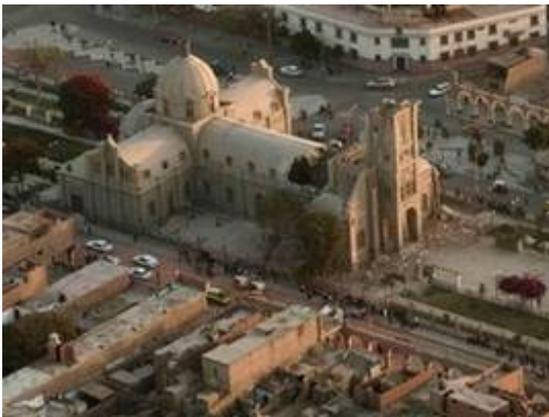
Figure 29. Church “Señor de Luren”, Ica

This church (Figure 29a) was built at the beginning of the XX century, and restored in 1943. One of its lateral towers collapsed during the Nazca earthquake that took place on November 12, 1996, but it was rebuilt in 2004. This church is built mostly with clay bricks and reinforced with concrete frames.

The church's ground floor is cross-shaped (Figure 29c) and there are still remains of a main tower and two smaller towers on its entrance area. Behind these towers, a 12 m. high (approx.) nave is located, joint by a dome to two other vaults. The two lateral towers had hollow columns, made of clay bricks (Figure 29b).

The earthquake caused the collapse of all the three towers (Figure 29b). The main tower collapsed inside the church, causing main vault's partial collapse (Figure 29d). The vault

was supported by two lateral walls that haven't completely collapsed, but that present diagonal fissures.
